Aquatic Vegetation Meandering Survey

Survey Date 15 August 2018
Observers Phillip Oswald, Garrett Brossart
Date of Report 13 September 2018
Report Author Phillip Oswald, Moriya Rufer

Lake Summary

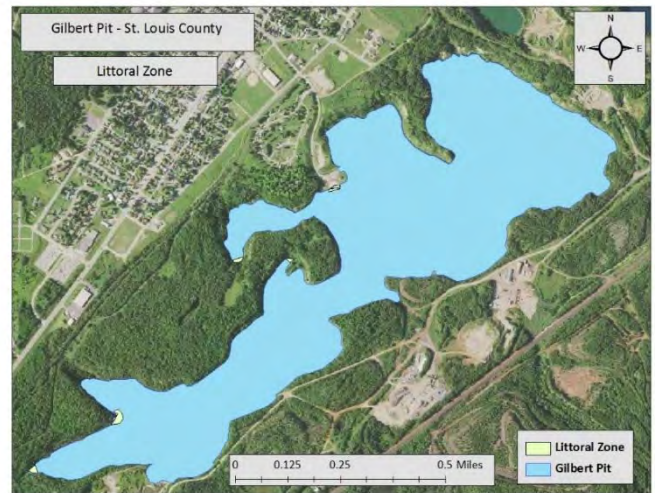
Figure 1: Gilbert Pit littoral zone, St. Louis County, MN.

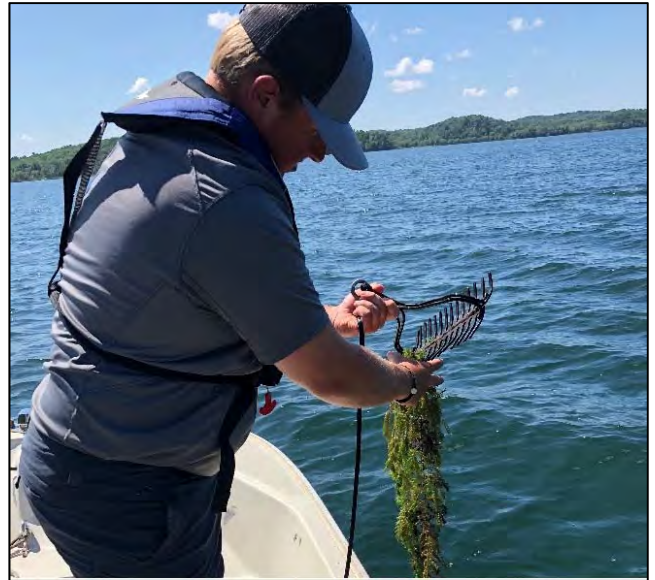
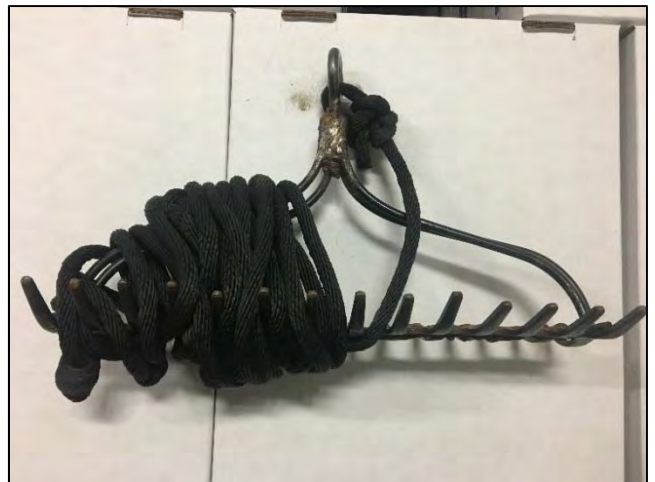
A double-headed, weighted garden rake attached to a rope (Figure 2 and 3) was used to survey vegetation. Vegetation that was found under the surface by use of the double-headed garden rake was assigned a number between 0 and 4; 0 being absent, 1 being rare ($\leq 1/3$ of the rake head covered), 2 being scattered ($>1/3$ but $\leq 2/3$ of the rake head covered), 3 being common ($>2/3$ of the rake head covered), and 4 being abundant (plants over top of rake head). Plant identification followed Blickenderfer (2007).

Figure 2 and 3: Double-headed, weighted garden rake, attached to a rope used to survey aquatic vegetation

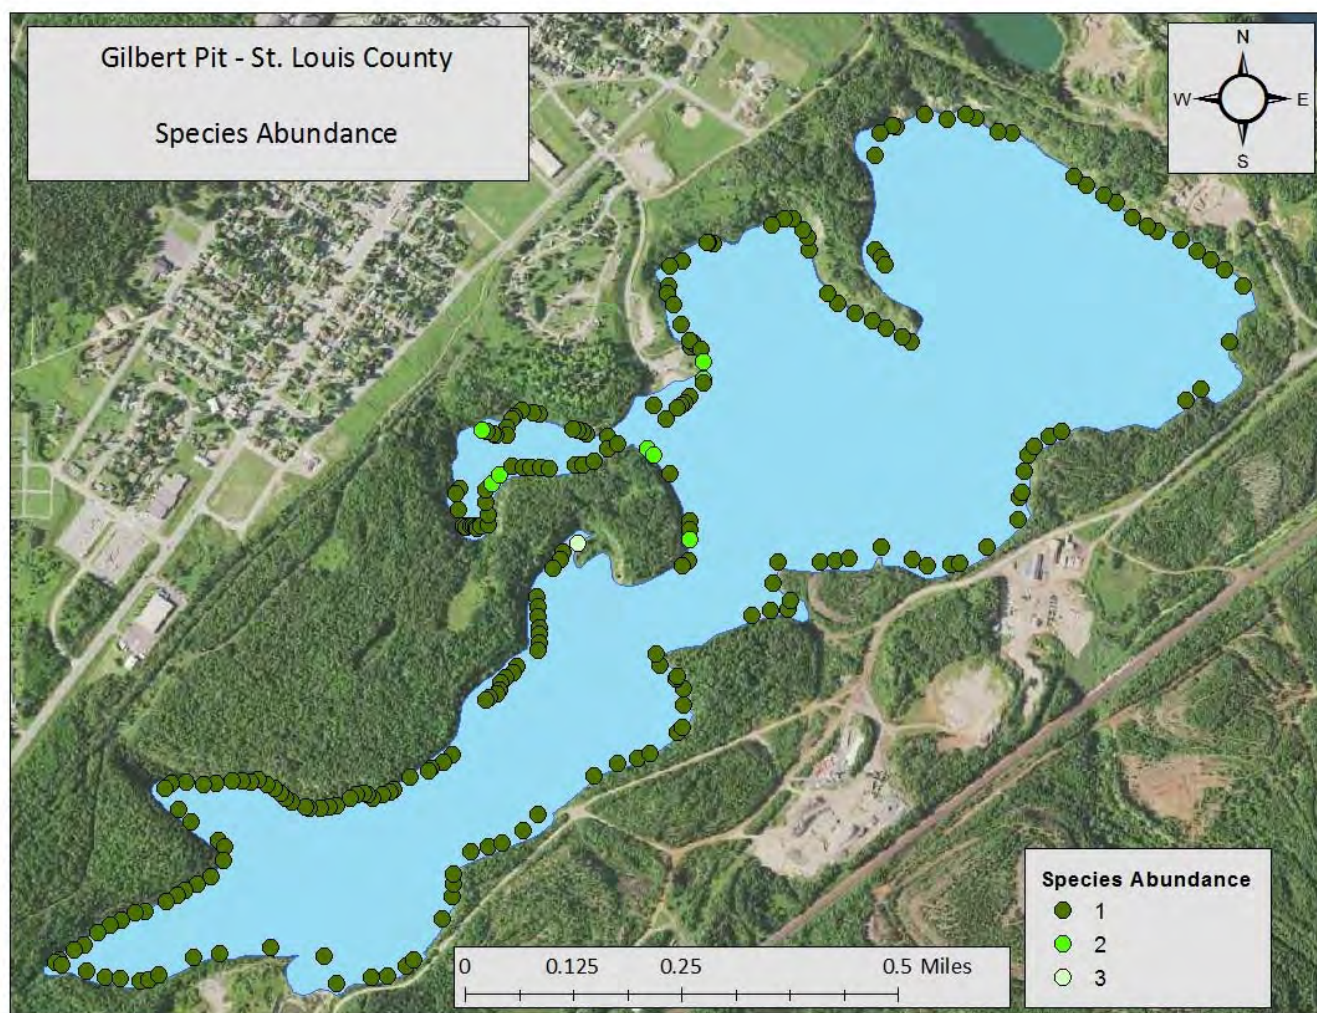
Three different types of native plants were found across the sampling area, as well as the invasive. (Figure 4). Eurasian water milfoil was the only invasive plant found during the summer survey, and the most abundant plant found (Figures 5 & 6). No native northern milfoil was found during the survey, so there doesn't appear to be a risk of milfoil hybridization.

Figure 4: Number of species present at sample points in Gilbert Pit, St. Louis County, MN, 15 August 2018, 2018.

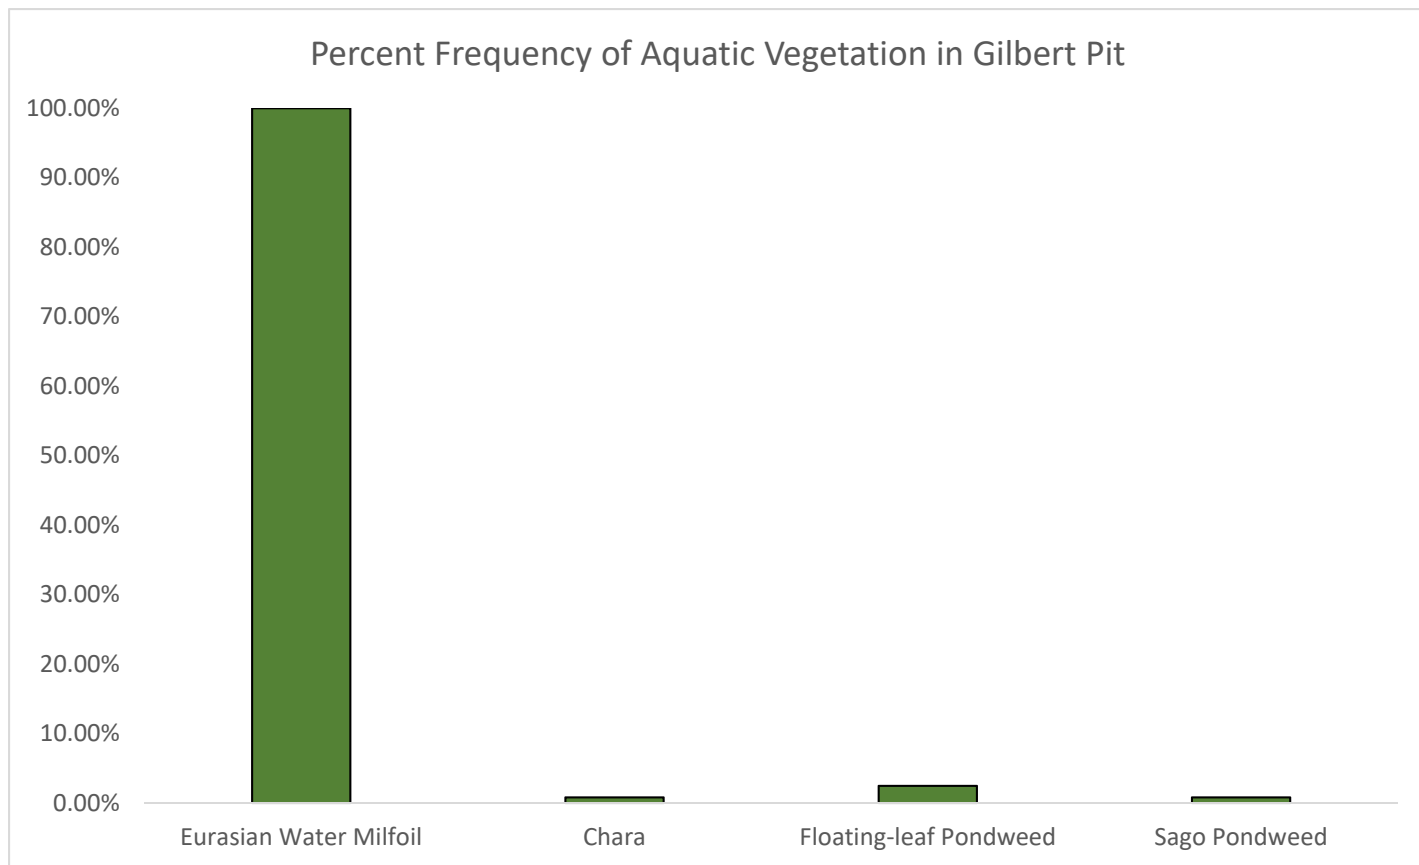
Figure 5: Frequency of aquatic plant species in Gilbert Pit 1 August 2018, 2018.

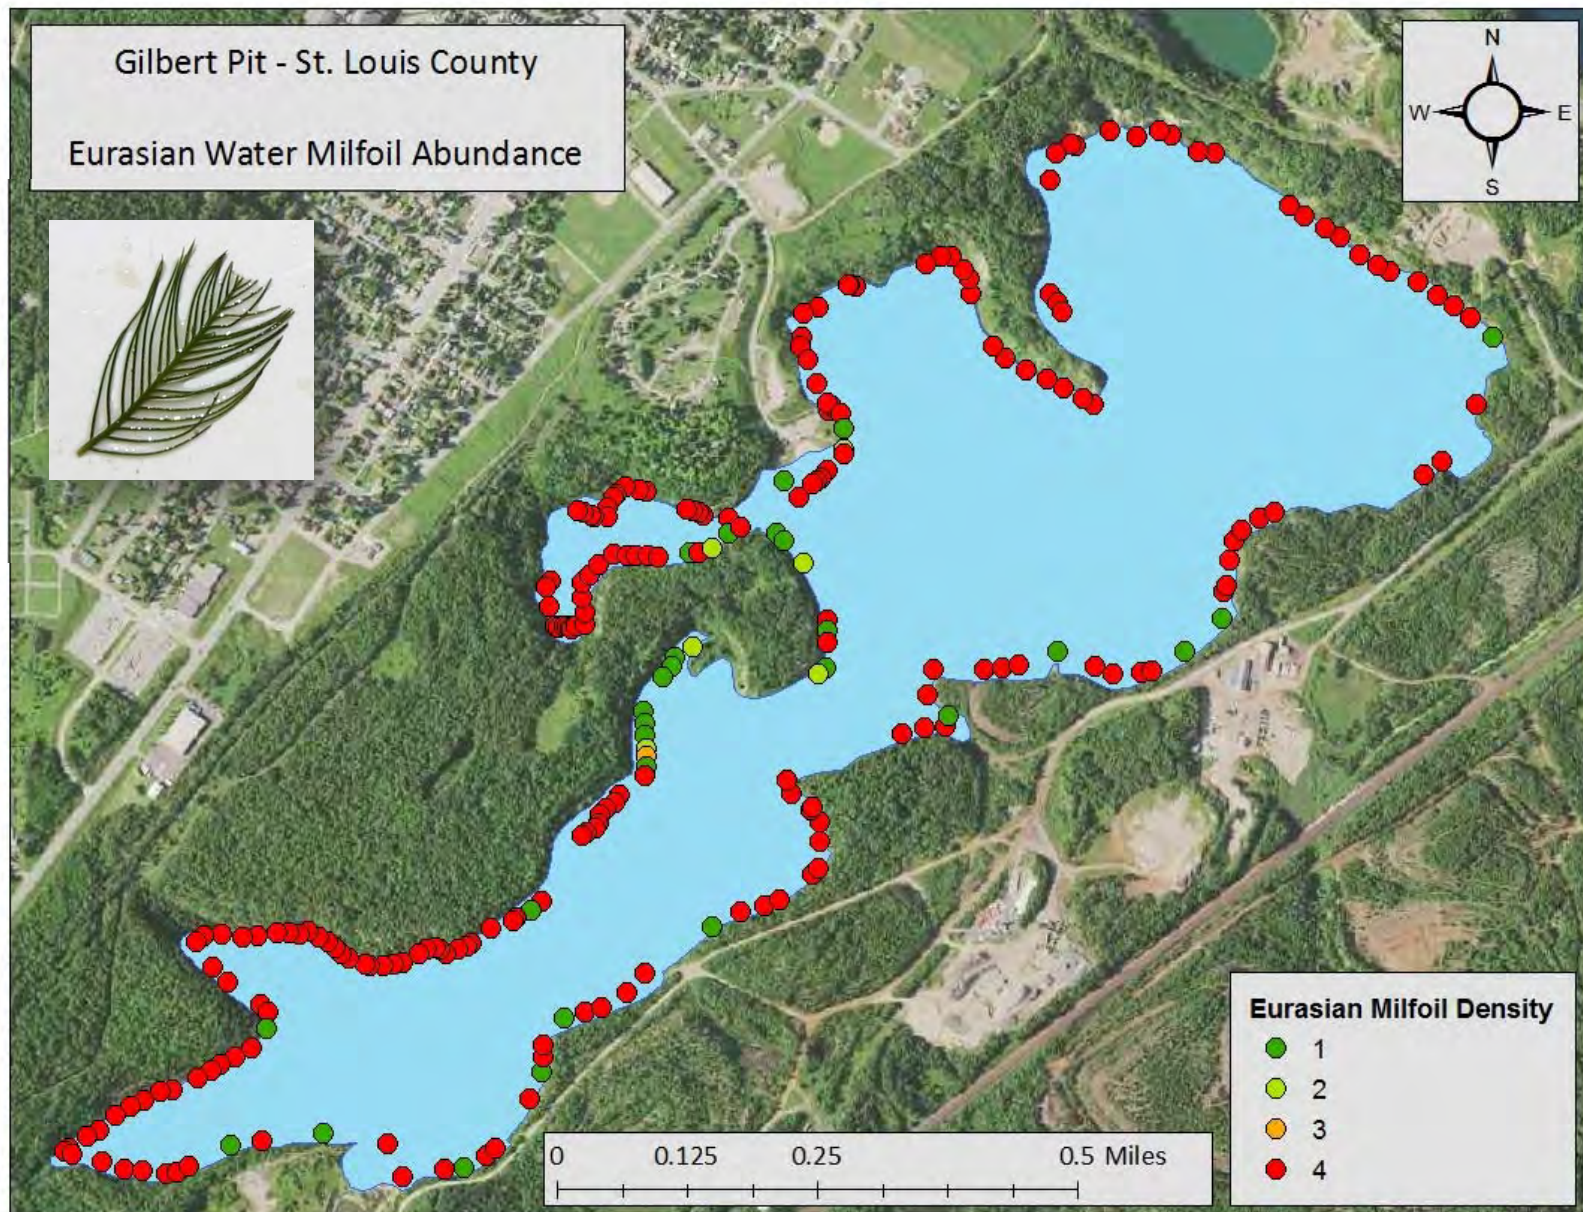
Figure 6: Density of Eurasian watermilfoil (*Myriophyllum spicatum*) at sample points in Gilbert Pit, St. Louis County, MN, 15 August 2018.

Zebra mussels and Eurasian watermilfoil (EWM) were found on Gilbert Pit during the survey. EWM was found all throughout the lake, mainly in high densities. Zebra mussels also appear to be thriving in the lake. Majority of rock piles were covered with colonies of zebra mussels.

Due to the abundance of EWM and Zebra mussels, those leaving Gilbert Pit should make sure and decontaminate their boats. Perhaps a sign could be posted by the access that gives the location of the nearest decontamination station.

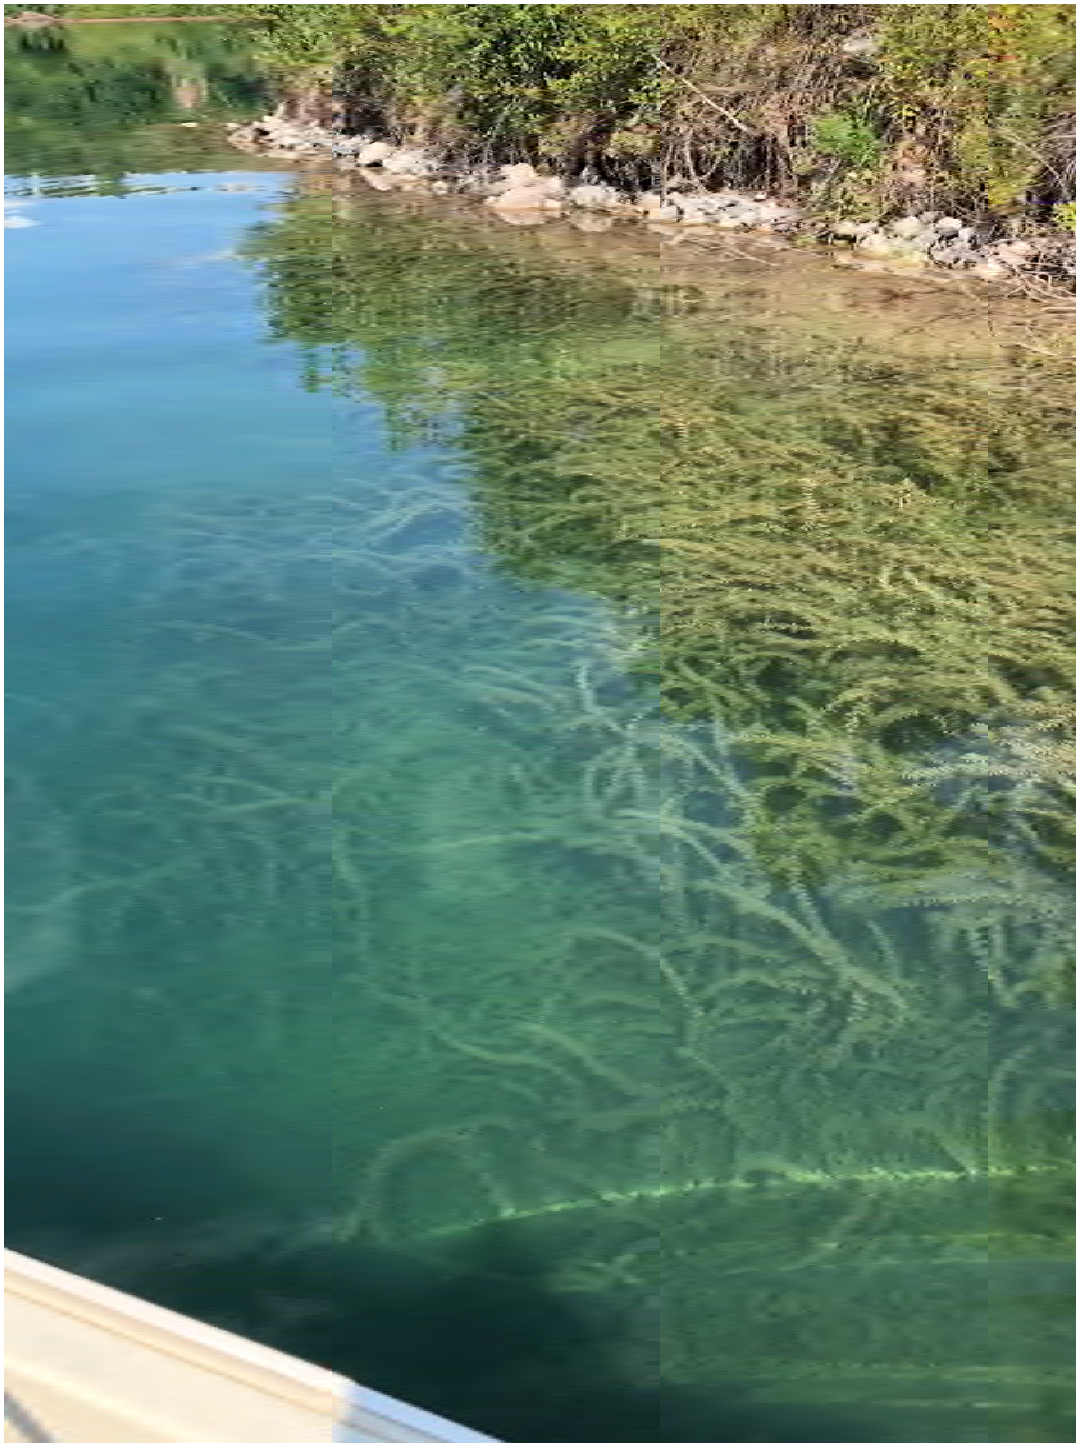
Figure 3. Eurasian water milfoil in Gilbert Pit.

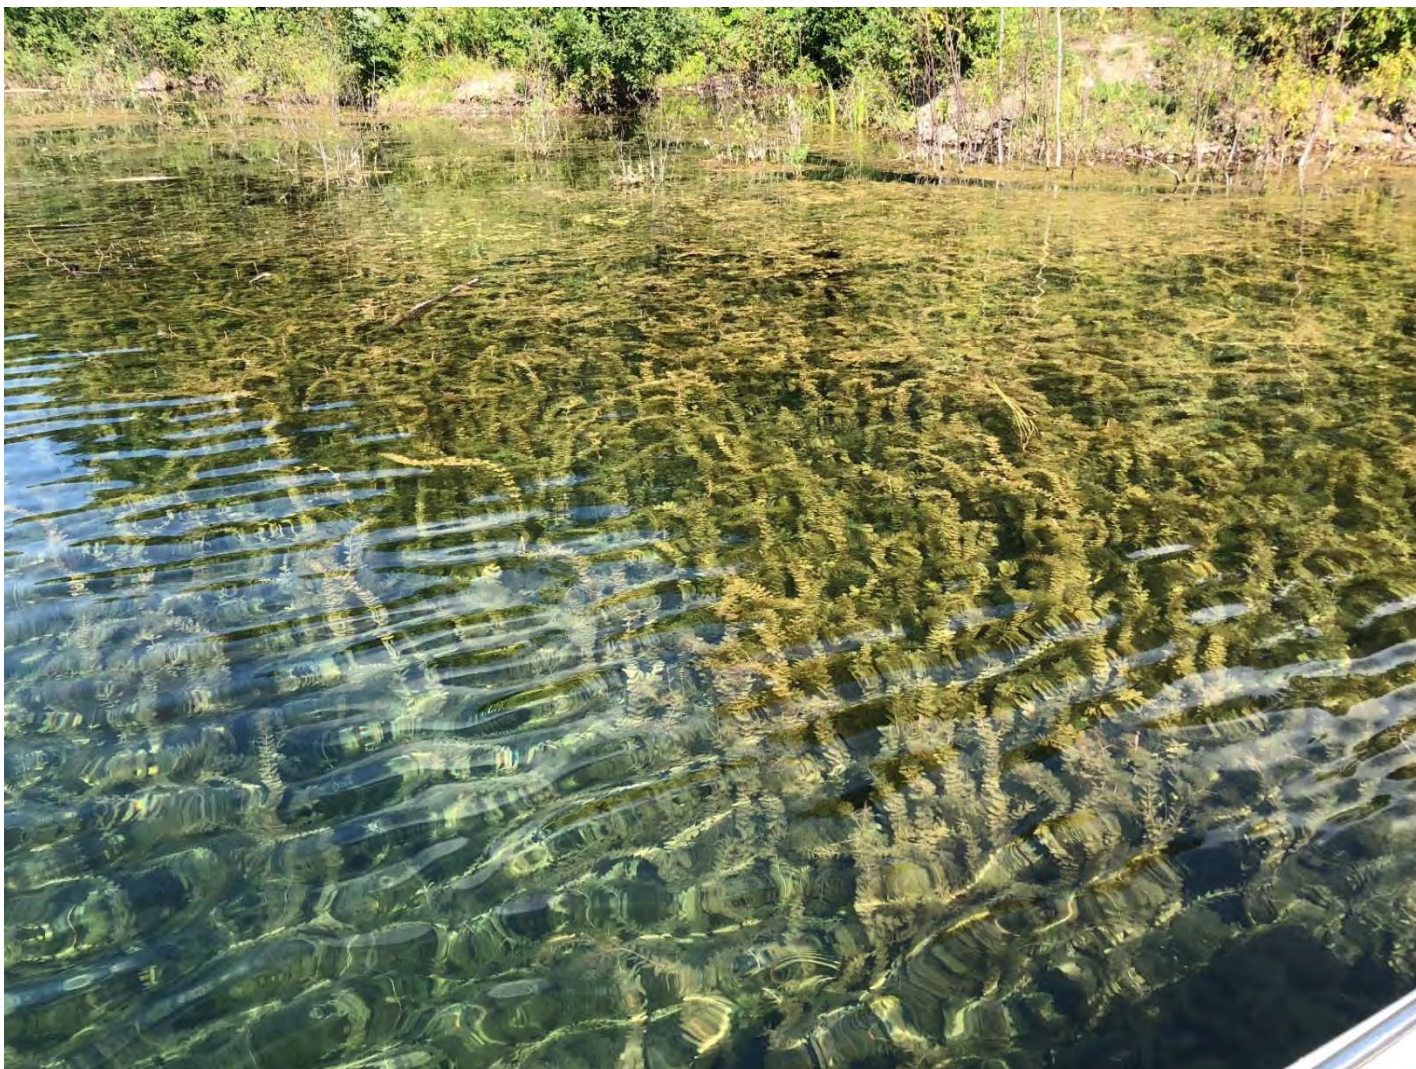
Figure 4. Very dense Eurasian watermilfoil in Gilbert Pit.

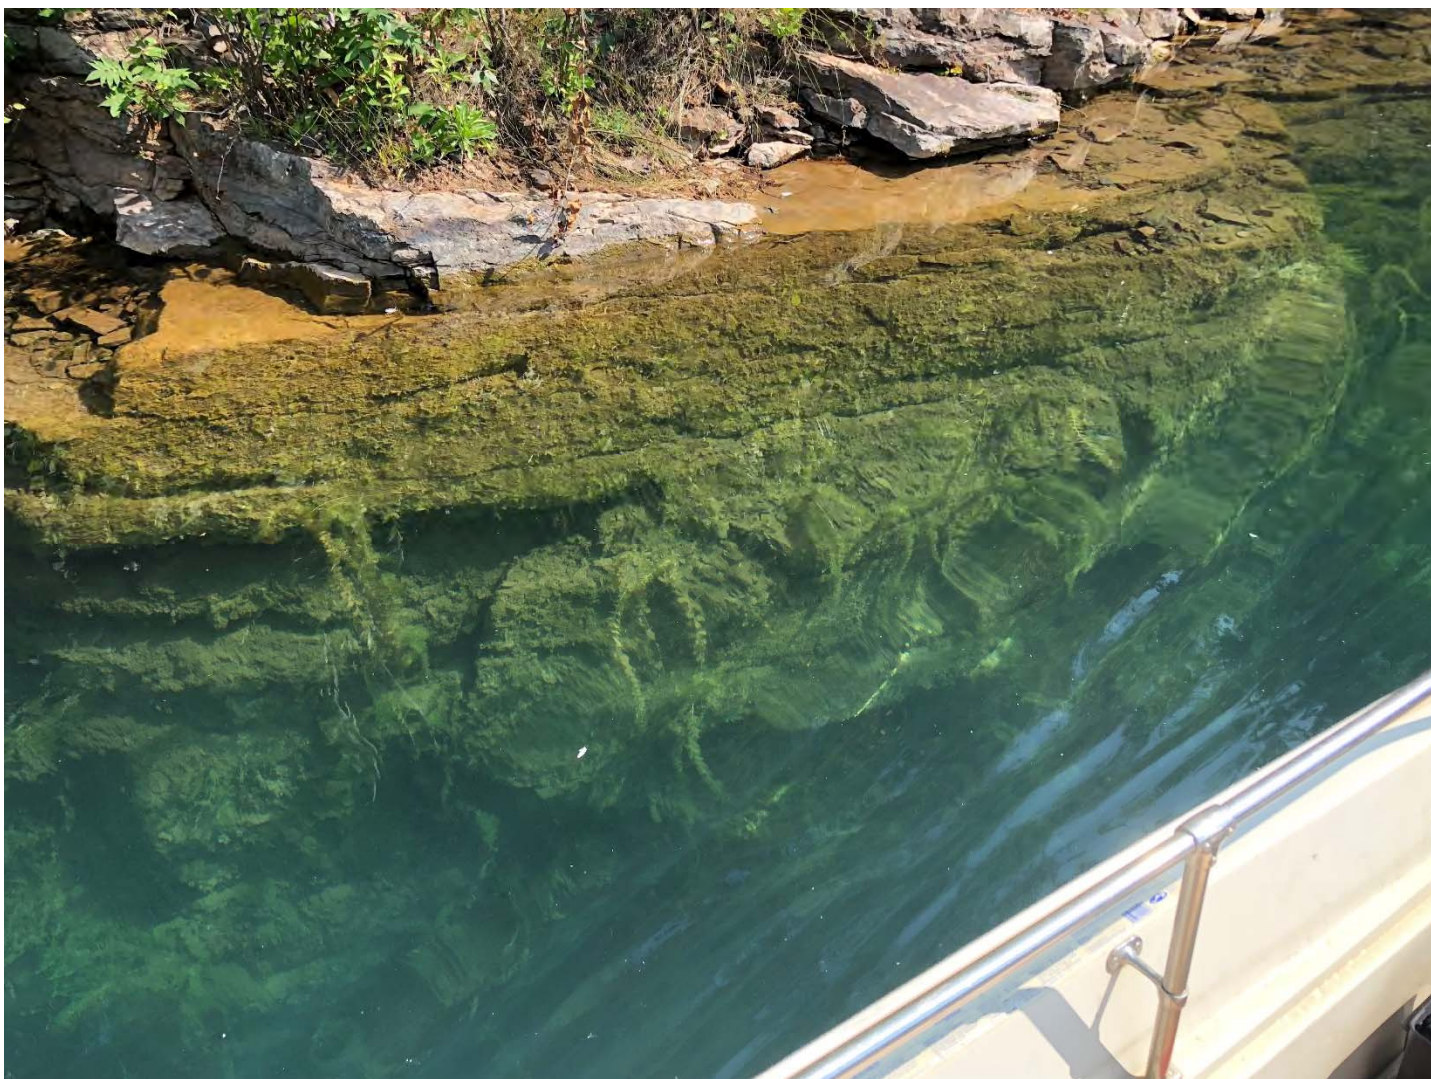
The Minnesota DNR lists the littoral area of Gilbert Pit to be approximately 7% of the total surface area. Vegetation was found all around the lake, either growing out of the cliffs, or in the substrate in shallow areas in bays.

Figure 5. Eurasian watermilfoil growing out of the cliff in Gilbert Pit.
