Lake Vermilion (69 - 0378 - 00)

Aquatic Vegetation Survey

Lake: Lake Vermilion

Date of inspection: June 6-10, 2016

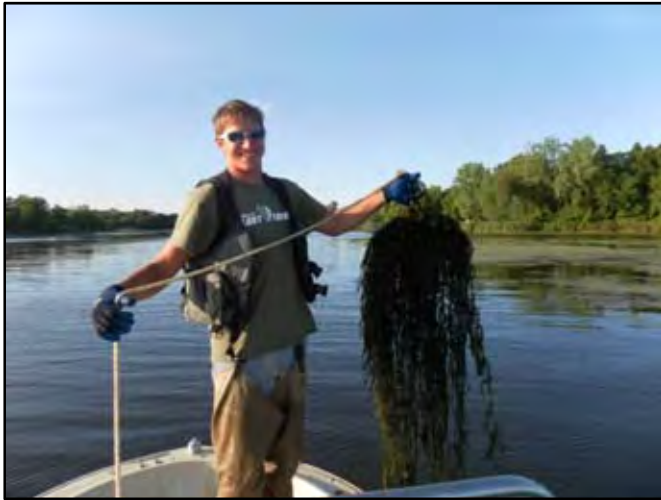
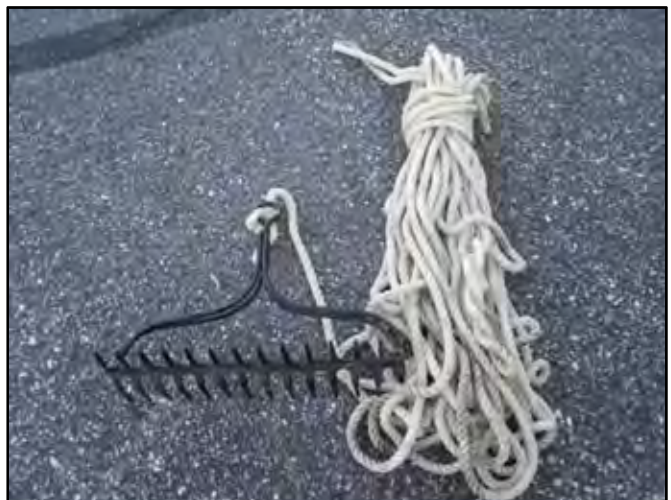
Figures 1 and 2. Double-headed, weighted garden rake, attached to a rope used to survey aquatic vegetation.

A double-headed, weighted garden rake, attached to a rope (Figure 1 and 2) was used to survey vegetation. Vegetation that was found under the surface by use of the double-headed garden rake was assigned a number between 1 and 4; 1 being rare ($\leq 1/3$ of the rake head covered), 2 being scattered ($>1/3$ but $\leq 2/3$ of the rake head covered), 3 being common ($> 2/3$ of the rake head covered), and 4 being abundant (plants over top of rake head). Plant identification followed Blickenderfer (2007).

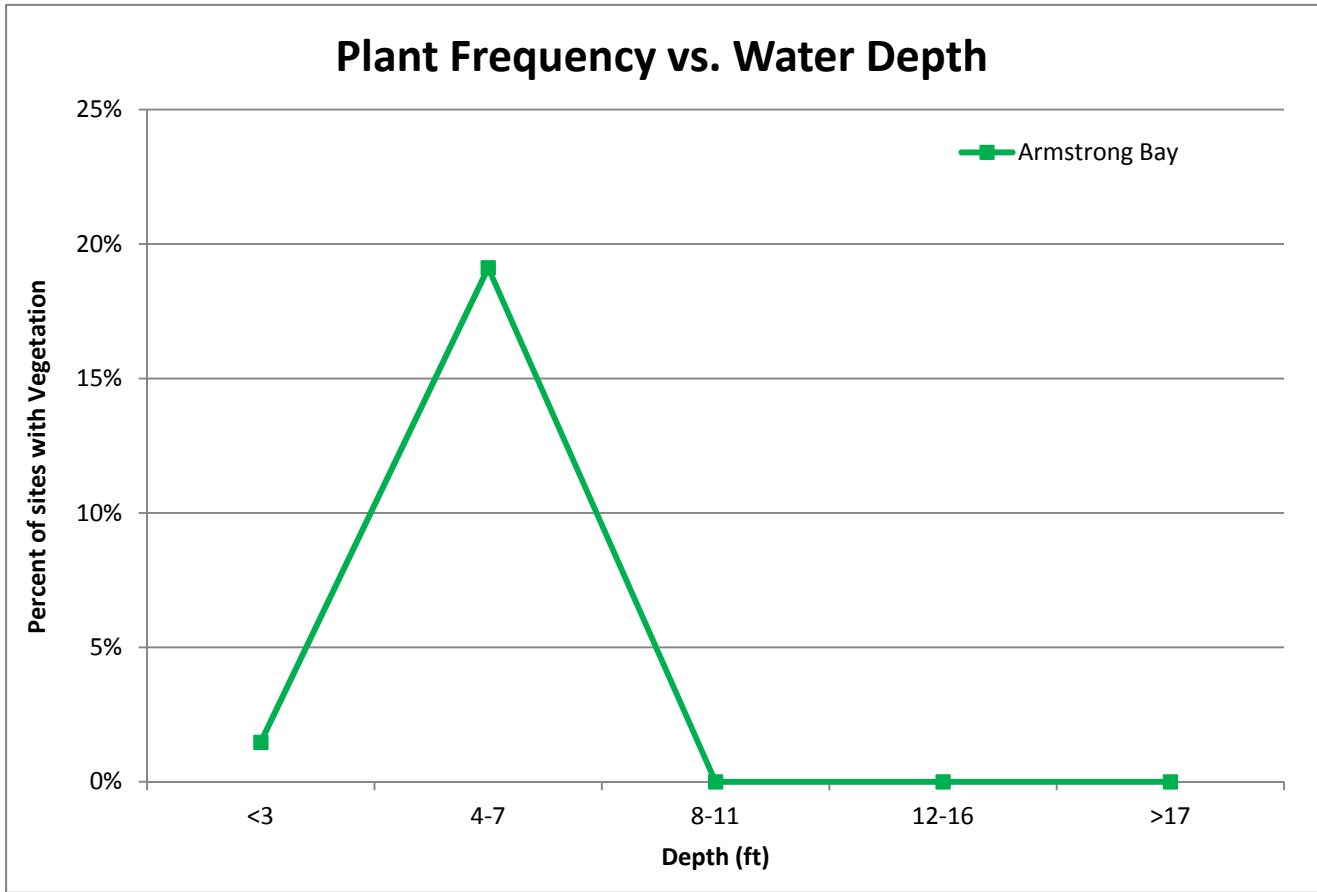
Figure 8. Frequency of vegetation vs. water depth, Armstrong Bay, Lake Vermilion, St. Louis County, MN: June 8, 2016.

Sampling occurred to a maximum depth of 25 feet; however, no plants were found to be growing beyond 7 feet of water. Plant abundance was greatest between 4-7 feet of water. As depths increased beyond that range, the presences of vegetation decreased and became less dense (Figure 8).

Of the 68 sampled locations in Armstrong Bay, 54 sites had no vegetation present.

Armstrong bay was very tea-stained, which decreases the area at which plants can grow. No plants were found in the central portion of the bay although the bay is fairly shallow.

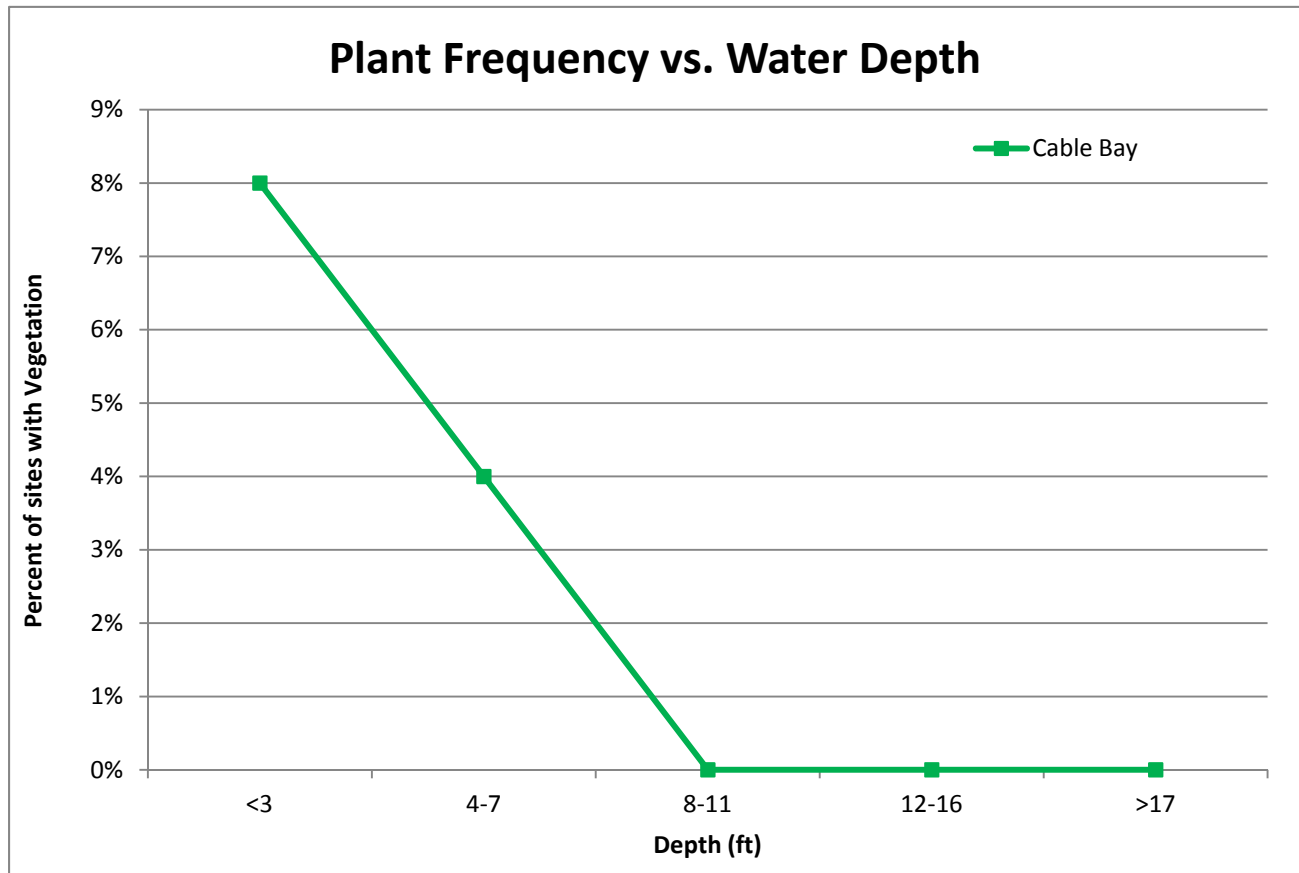
Figure 12. Frequency of vegetation vs. water depth, Cable Bay, Lake Vermilion, St. Louis County, MN: June 8, 2016.

Sampling occurred to a maximum depth of 26 feet; however, no plants were found to be growing beyond 7 feet of water. Plant abundance was greatest between one and eleven feet of water. As depths increased beyond that range, the presences of vegetation decreased and became less dense (Figure 12).

Of the 25 sampled locations in Cable Bay, 22 sites had no vegetation present.

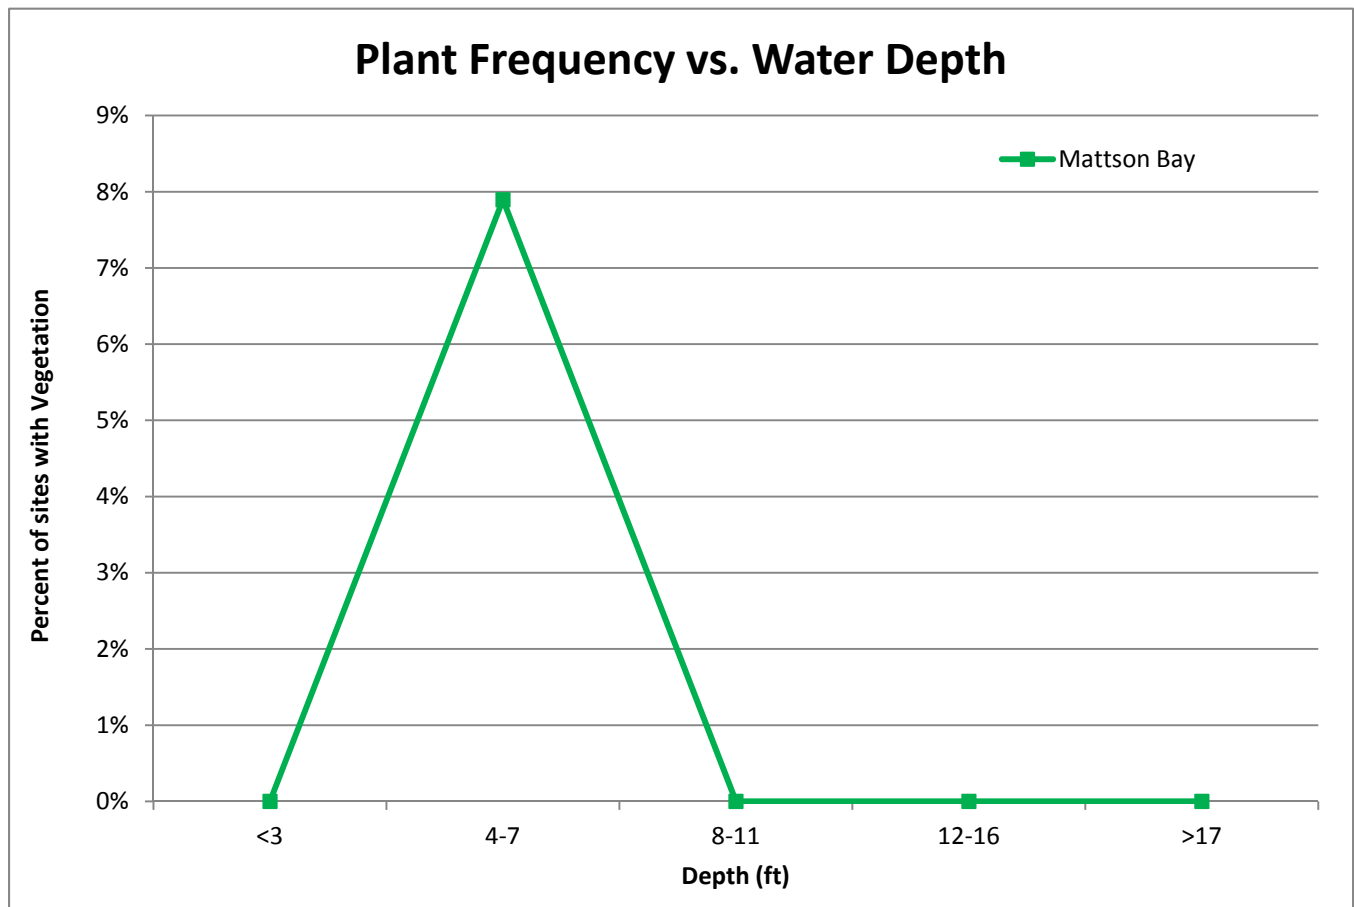
Figure 16. Frequency of vegetation vs. water depth, Mattson Bay, Lake Vermilion, St. Louis County, MN: June 8, 2016.

Sampling occurred to a maximum depth of 26 feet; however, no plants were found to be growing beyond 7 feet of water. Plant abundance was greatest between four and seven feet of water. As depths increased beyond that range, the presences of vegetation decreased and became less dense (Figure 16).

Of the 38 sampled locations in Mattson Bay, 35 sites had no vegetation present.

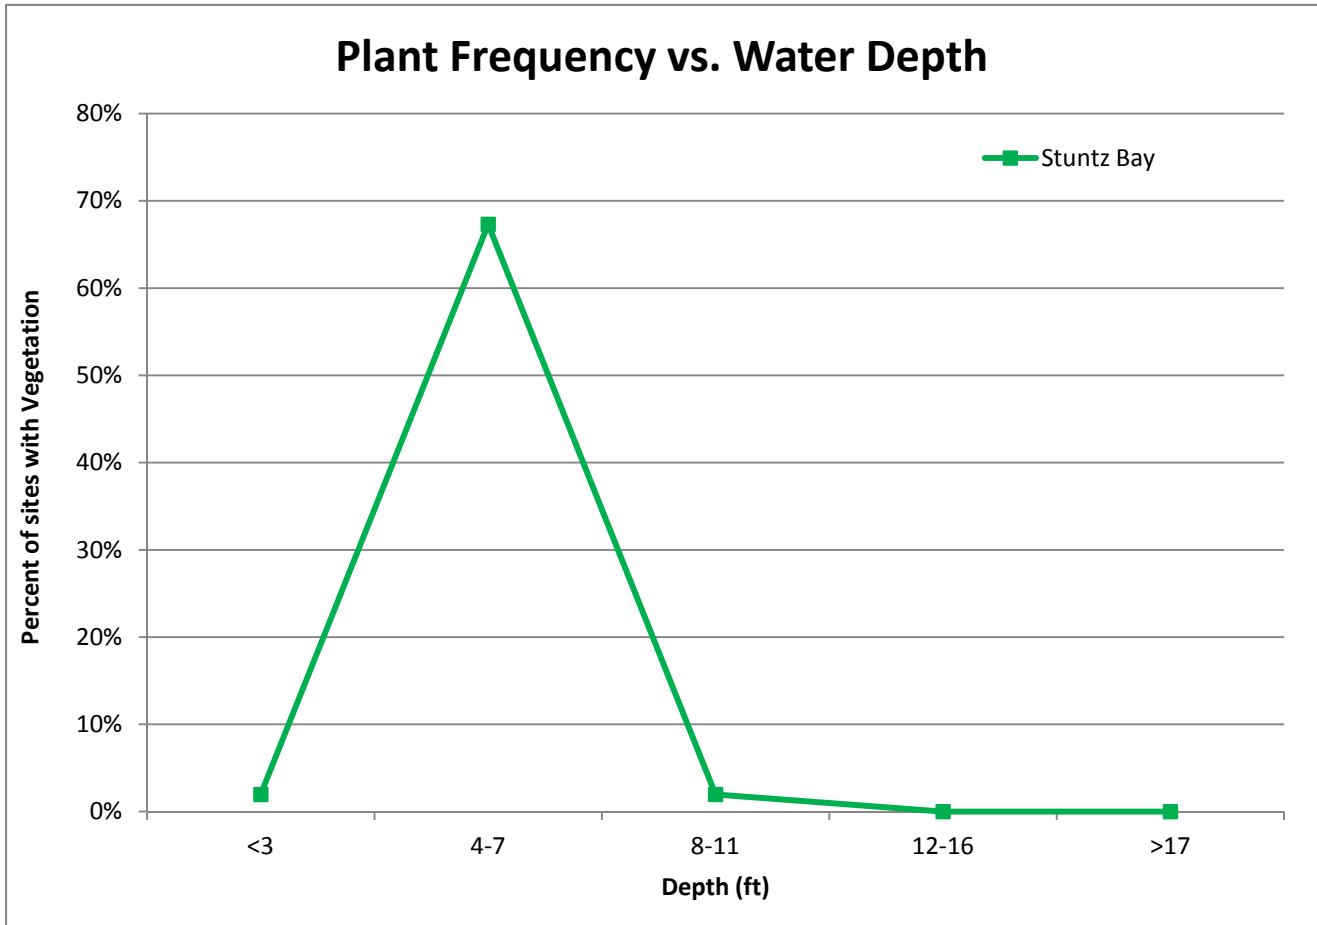
Figure 22. Frequency of vegetation vs. water depth, Stuntz Bay, Lake Vermilion, St. Louis County, MN: June 9, 2016.

Sampling occurred to a maximum depth of 17 feet; however, no plants were found to be growing beyond 15 feet of water. Plant abundance was greatest between four and seven feet of water. As depths increased beyond that range, the presences of vegetation decreased and became less dense (Figure 22).

Of the 153 sampled locations in Stuntz Bay, 44 sites had no vegetation present.

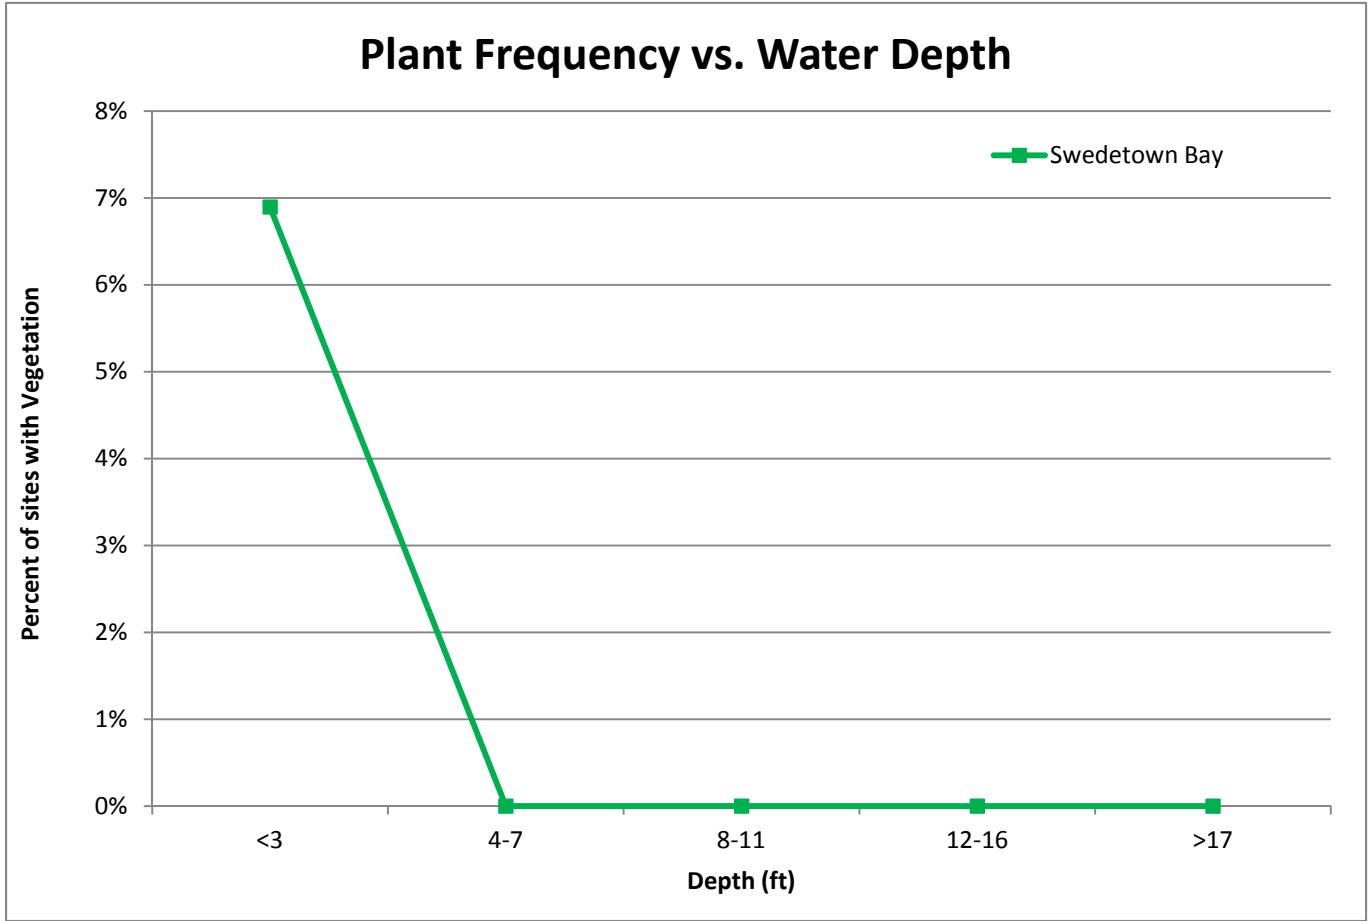
Figure 27. Frequency of vegetation vs. water depth, Swedetown Bay, Lake Vermilion, St. Louis County, MN: June 8, 2016.

Sampling occurred to a maximum depth of 25 feet; however, no plants were found to be growing beyond 3 feet of water. Plant abundance was greatest between one and three feet of water. As depths increased beyond that range, the presences of vegetation decreased and became less dense (Figure 27).

Of the 29 sampled locations in Swedetown Bay, 27 sites had no vegetation present.

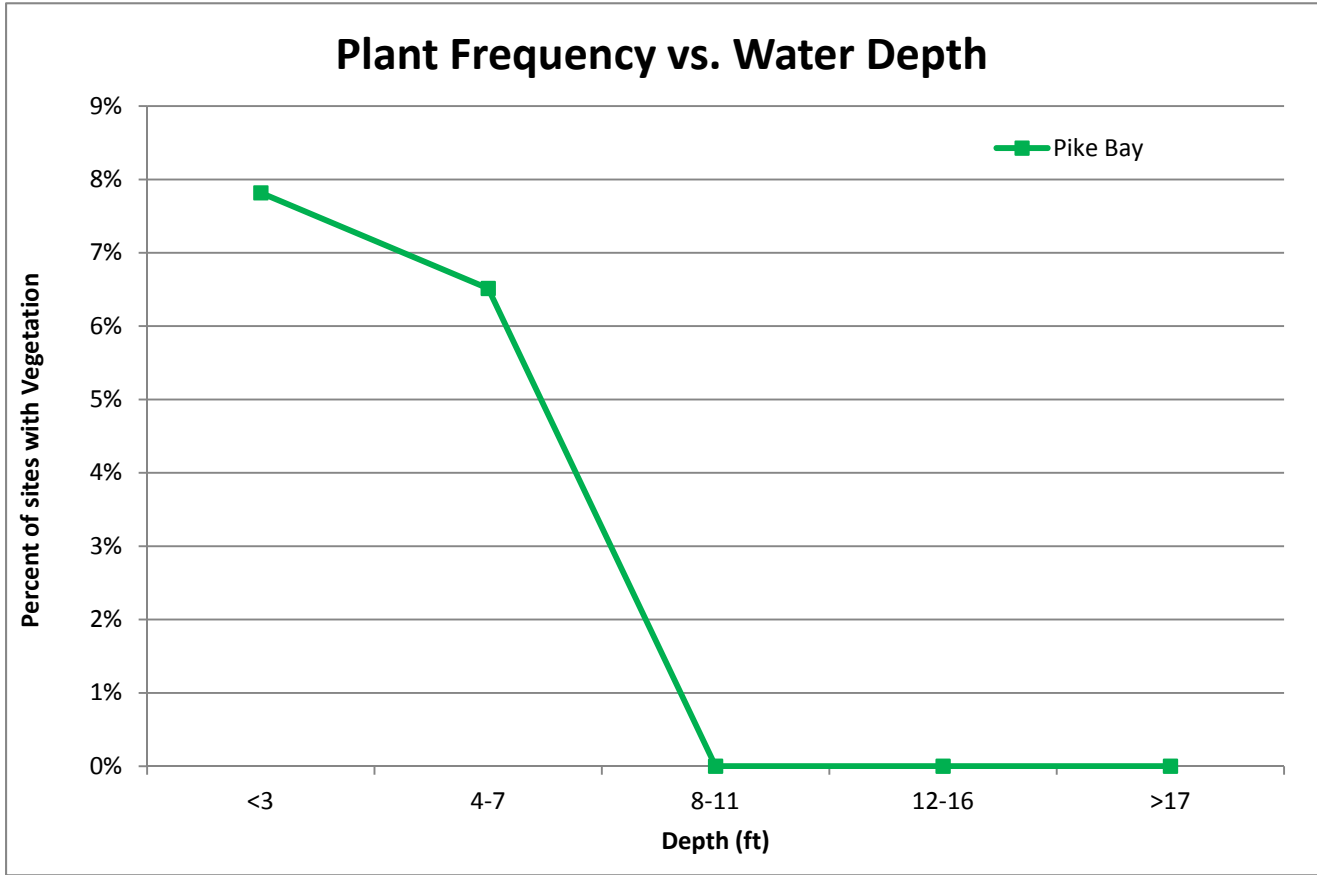
Figure 32. Frequency of vegetation vs. water depth, Pike Bay, Lake Vermilion, St. Louis County, MN: June 6 and 7, 2016.

Sampling occurred to a maximum depth of 15 feet; however, no plants were found to be growing beyond 6 feet of water. Plant abundance was greatest between one and six feet of water. As depths increased beyond that range, the presences of vegetation decreased and became less dense (Figure 32).

Of the 307 sampled locations in Pike Bay, 263 sites had no vegetation present. The water was very tea-stained, which decreases the depth at which plants can grow. Although the bay is fairly shallow, no plants were found beyond the edge of the bay.

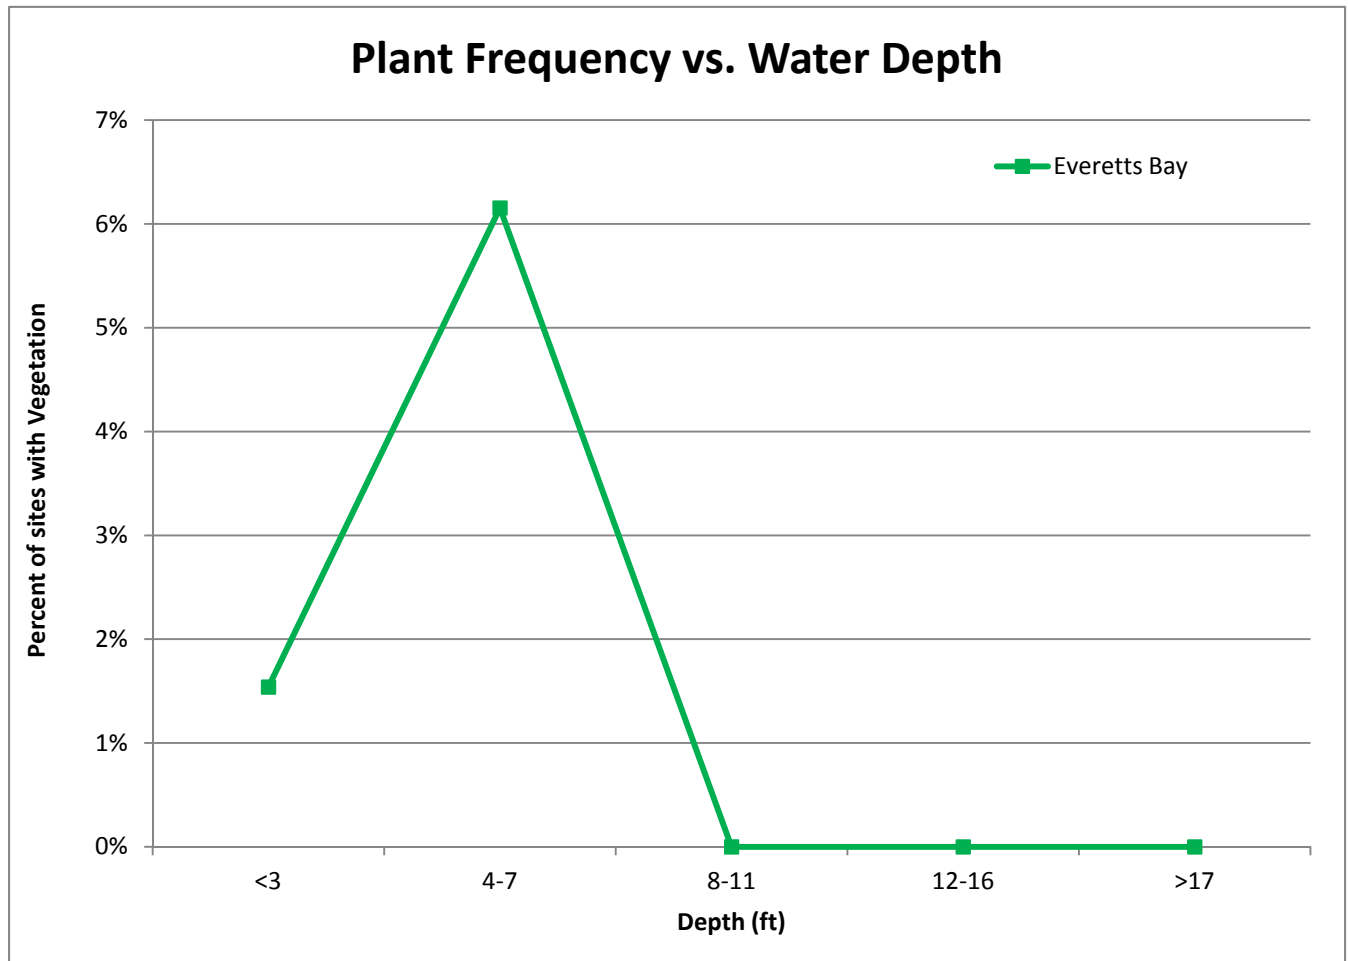
Figure 36. Frequency of vegetation vs. water depth, north of Everetts Bay, Lake Vermilion, St. Louis County, MN: June 8, 2016.

Sampling occurred to a maximum depth of 23 feet; however, no plants were found to be growing beyond 5 feet of water. Plant abundance was greatest between one and five feet of water. As depths increased beyond that range, the presences of vegetation decreased and became less dense (Figure 36).

Of the 65 sampled locations north of Everetts Bay, 60 sites had no vegetation present.

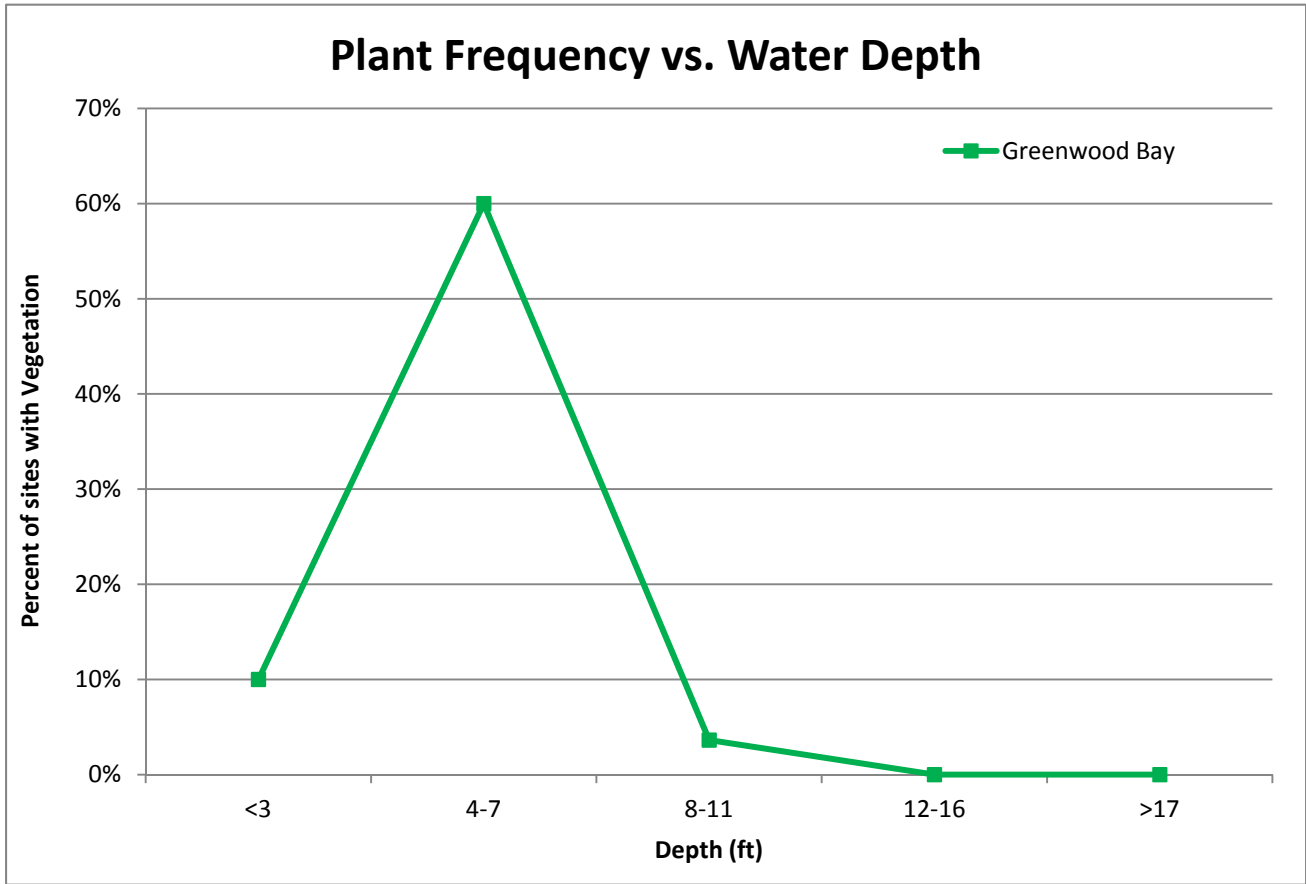
Figure 41. Frequency of vegetation vs. water depth, Gerenwood Bay, Lake Vermilion, St. Louis County, MN: June 9, 2016.

In Greenwood Bay, sampling occurred to a maximum depth of 14 feet; however, no plants were found to be growing beyond 8 feet of water. Plant abundance was greatest between two and eight feet of water. As depths increased beyond that range, the presences of vegetation decreased and became less dense (Figure 41).

Of the 110 sampled locations in Gerenwood Bay, 29 sites had no vegetation present.

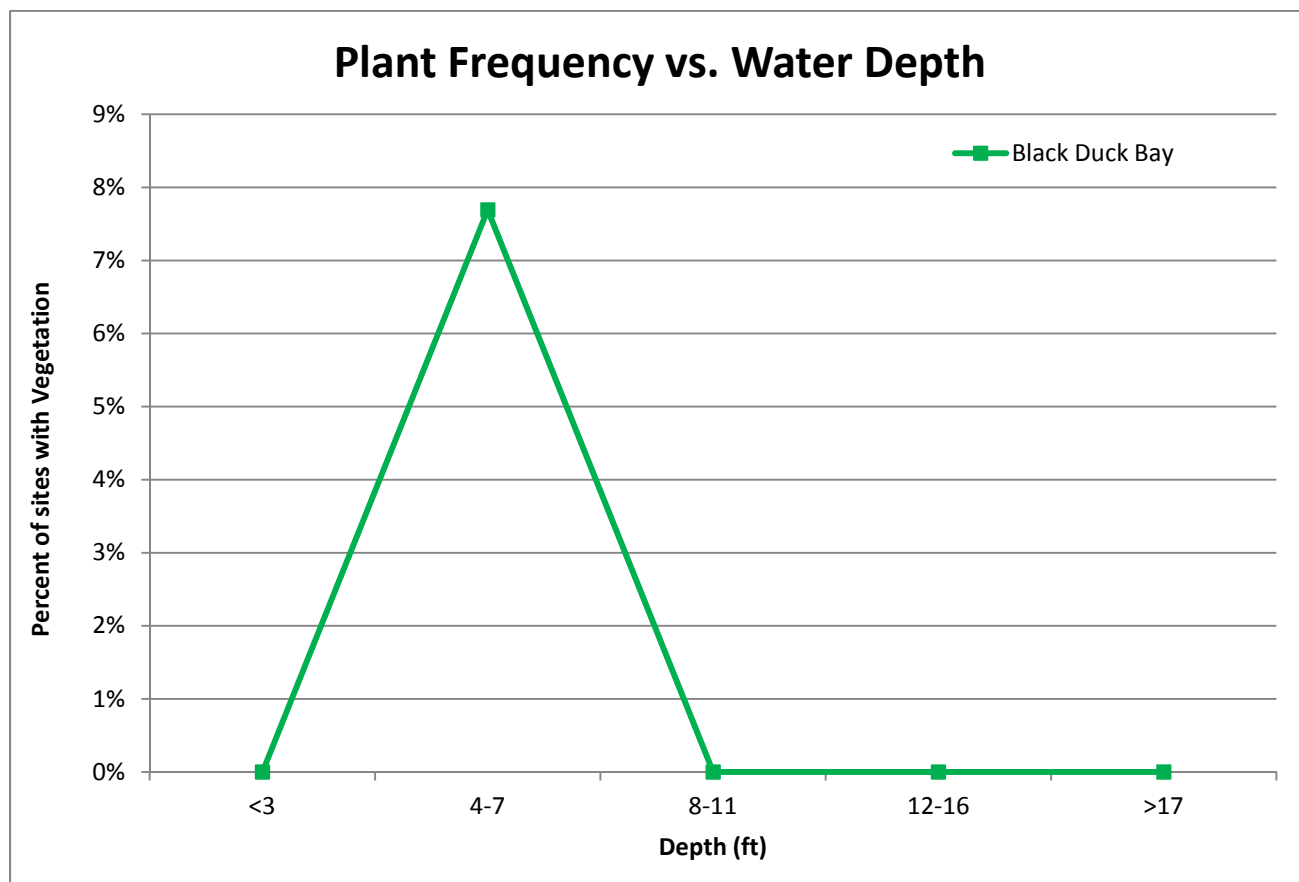
Figure 42. Frequency of vegetation vs. water depth, Black Duck Bay, Lake Vermilion, St. Louis County, MN: June 9, 2016.

In Black Duck Bay, sampling occurred to a maximum depth of 13 feet; however, no plants were found to be growing beyond five feet of water. Only one plant was found in the bay (Figure 42).

Of the 13 sampled locations in Black Duck Bay, 12 sites had no vegetation present.

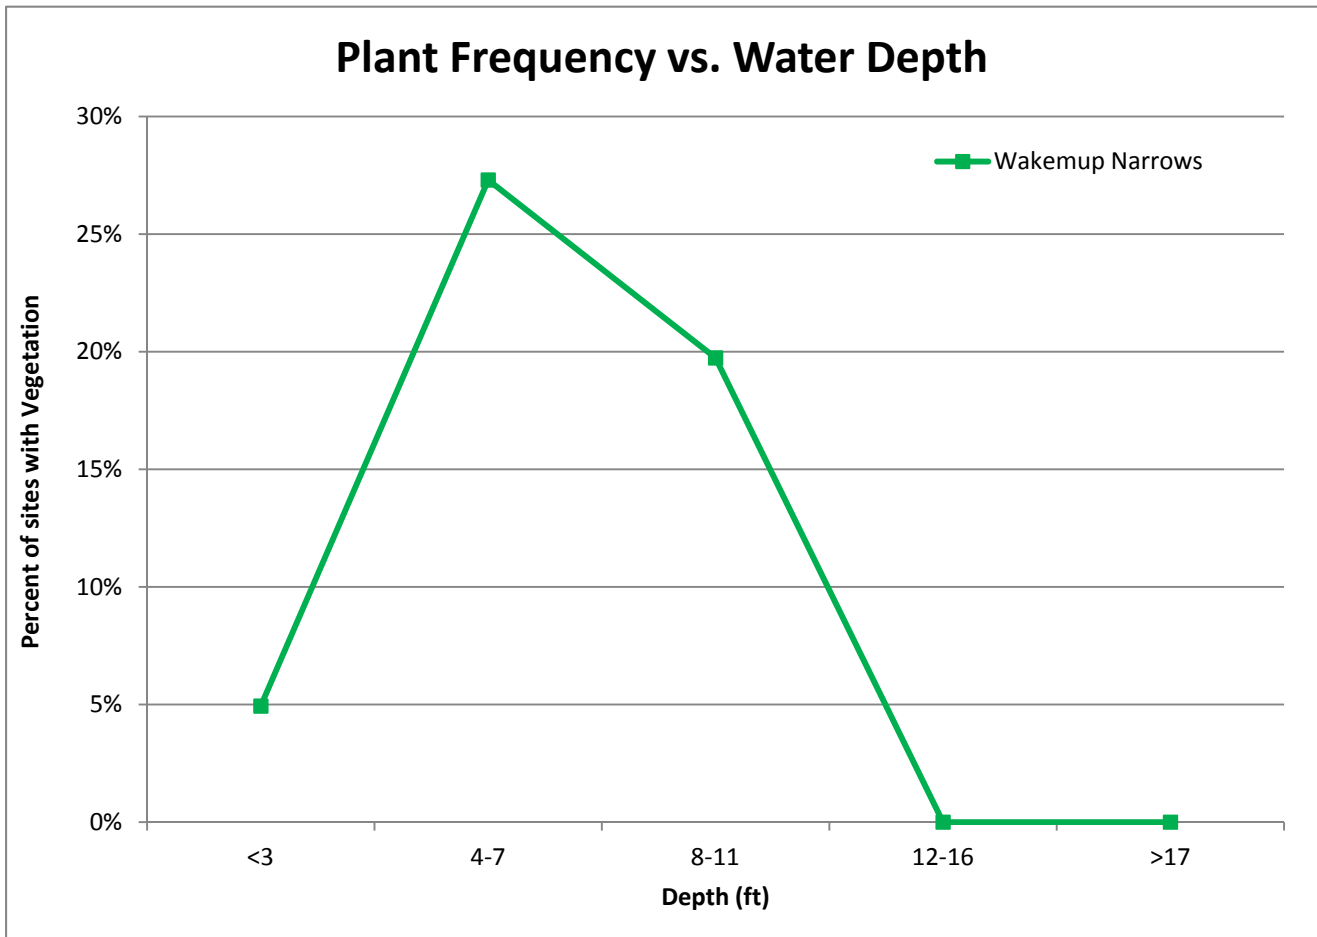
Figure 49. Frequency of vegetation vs. water depth, Wakemup Narrows, Lake Vermilion, St. Louis County, MN: June 9 and 10, 2016.

Sampling occurred to a maximum depth of 19 feet; however, no plants were found to be growing beyond 16 feet of water. Plant abundance was greatest between four and eleven feet of water. As depths increased beyond that range, the presences of vegetation decreased and became less dense (Figure 49).

Of the 289 sampled locations in Wakemup Narrows, 146 sites had no vegetation present.

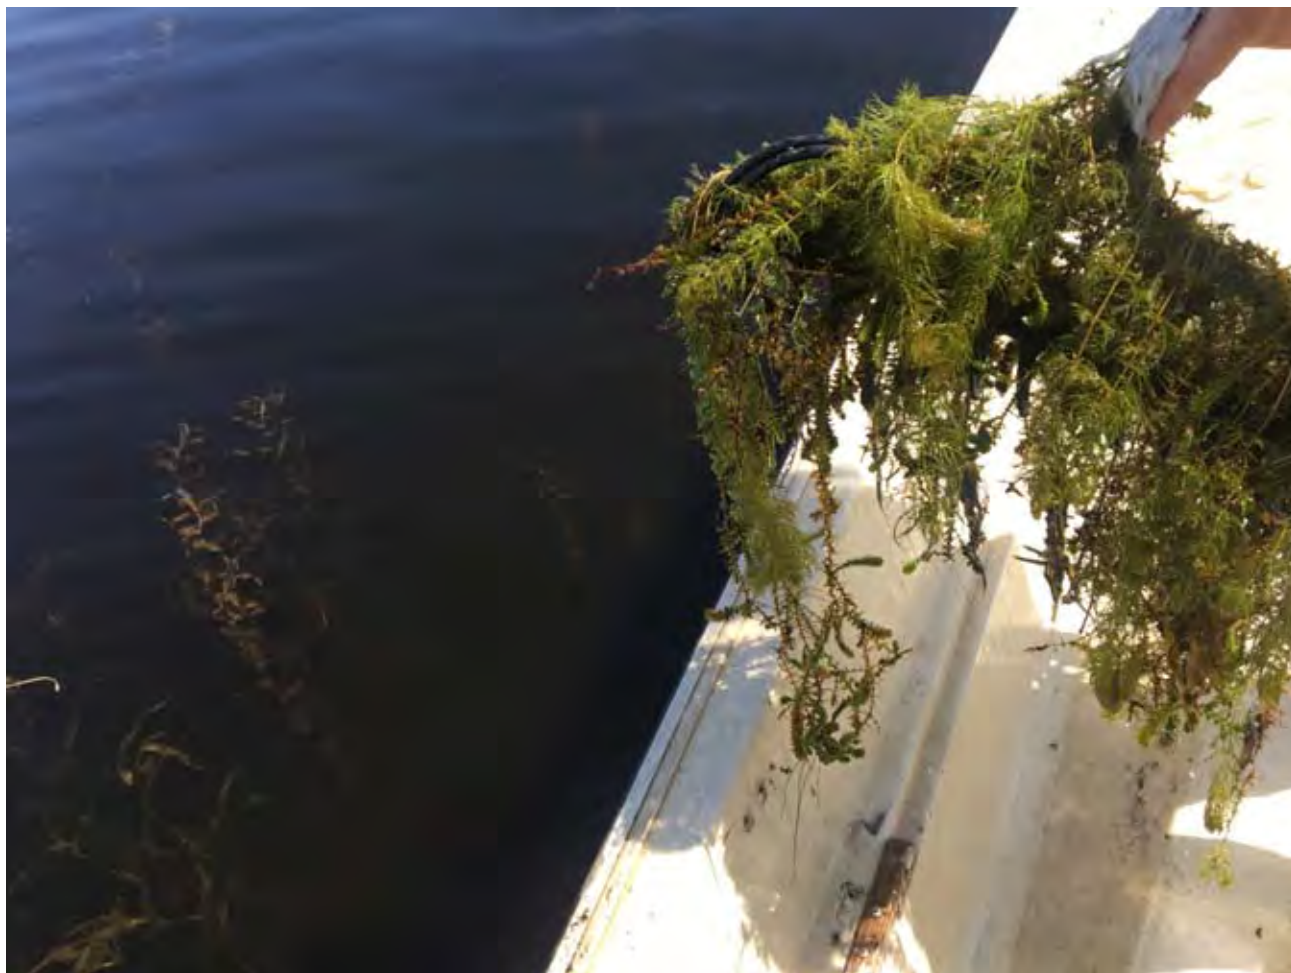
Figure 51. Sampling rake with many native aquatic plants in Lake Vermilion on June 6-10, 2016. White-stem pondweed can be seen in the background at the water's surface.

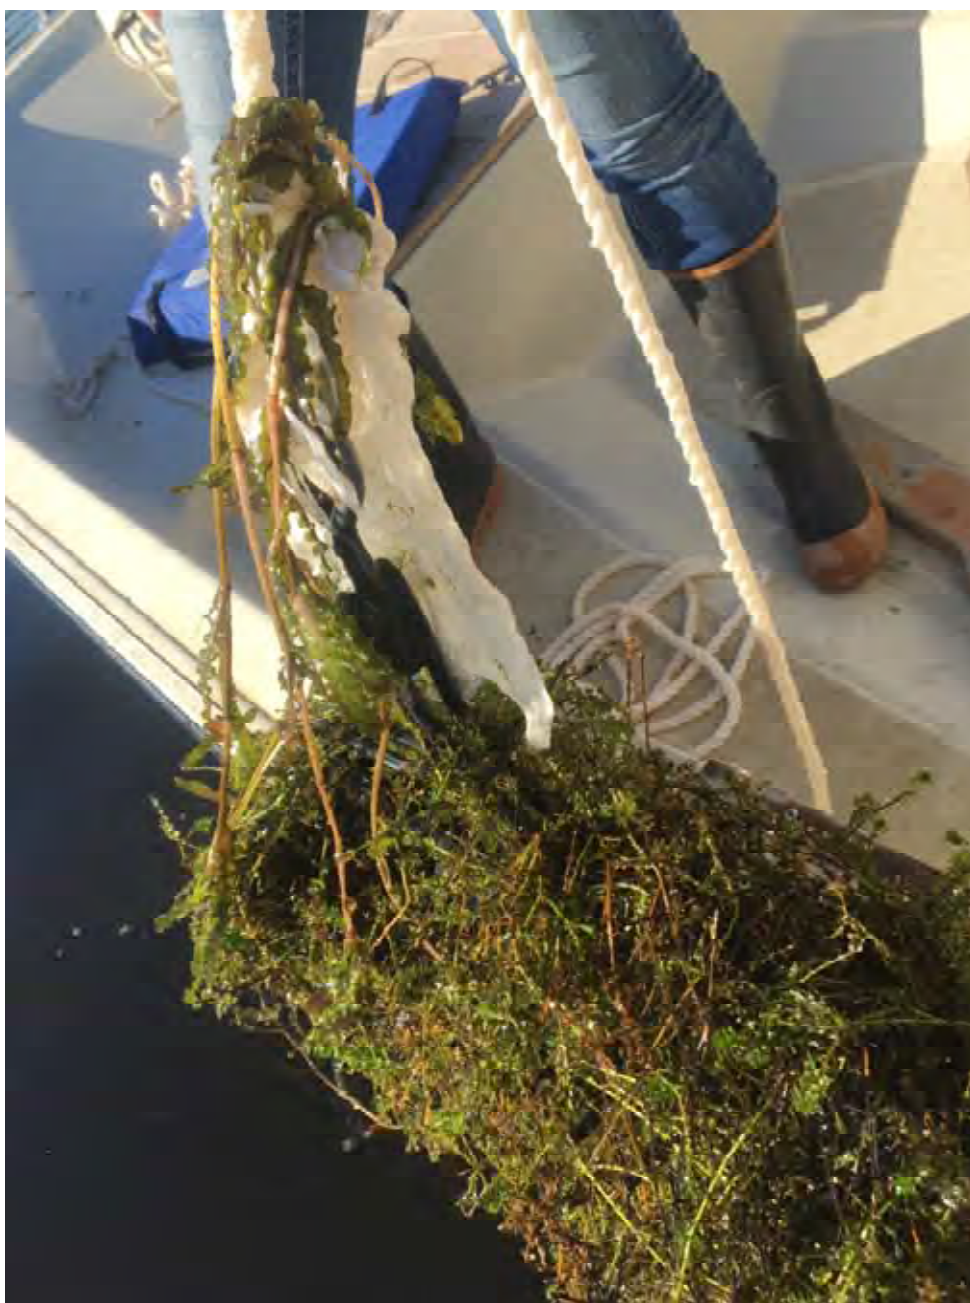
Figure 52. sampling rake with many native plants and a some curly-leaf.

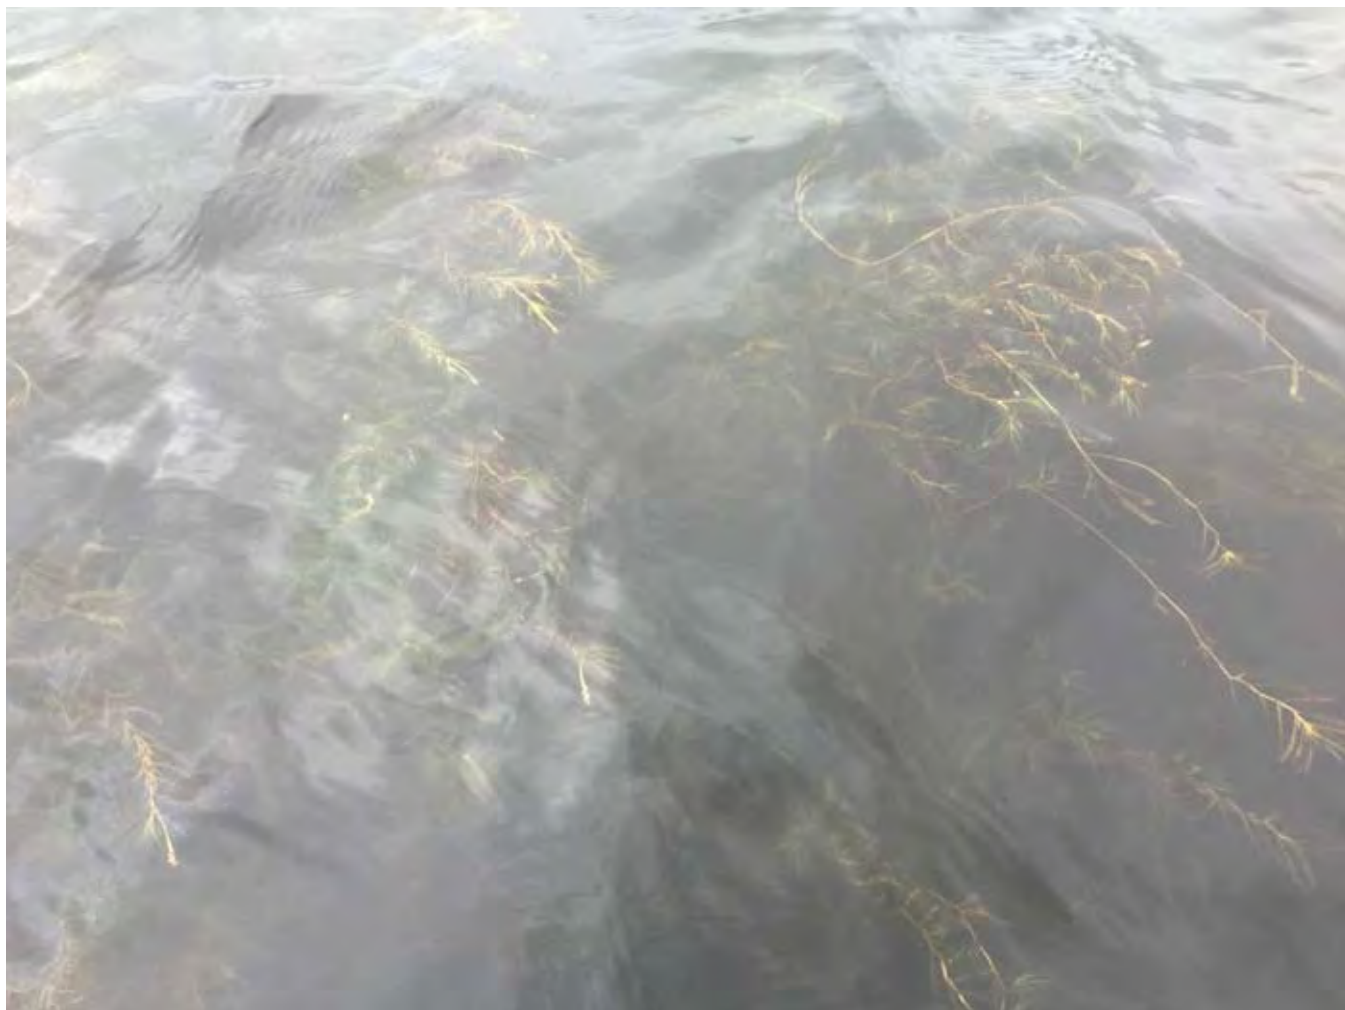
Figure 53. Curly-leaf Pondweed beds under clear water in Stuntz Bay.
