LAKE VERMILION (69 - 0378 - 00)

Aquatic Vegetation Survey

Lake: Lake Vermilion	DOW Number : 69-0378-00	Date of inspection: 6/ 5-9 & 11-15/17 and 8/14-18/17		
County: St. Louis	Observers: Emelia Hauck, Katherine Millette, Laura Geyen			
Author of report: Emelia Hauck		Date of report: October 5, 2017

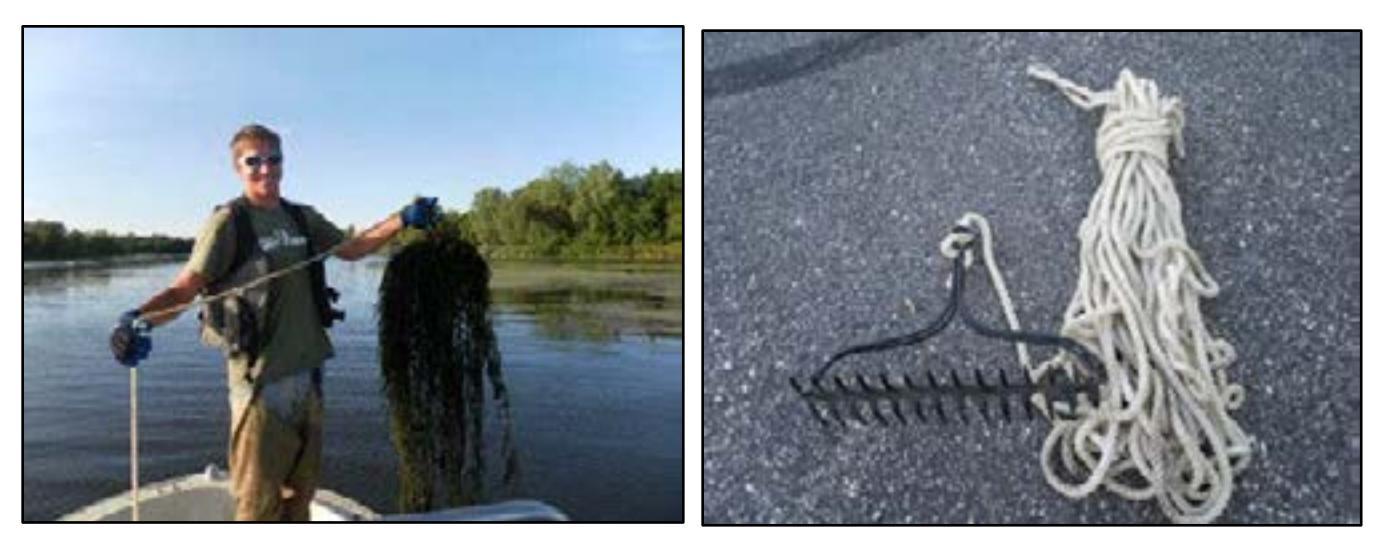
A double-headed, weighted garden rake, attached to a rope (Figure 1 and 2) was used to survey vegetation. Vegetation that was found under the surface by use of the double-headed garden rake was assigned a number between 1 and 4; 1 being rare ($\leq 1/3$ of the rake head covered), 2 being scattered ($\geq 1/3$ but $\leq 2/3$ of the rake head covered), 3 being common ($\geq 2/3$ of the rake head covered), and 4 being abundant (plants over top of rake head). Plant identification followed Blickenderfer (2007).

Figures 1 and 2. Double-headed, weighted garden rake, attached to a rope used to survey aquatic vegetation.

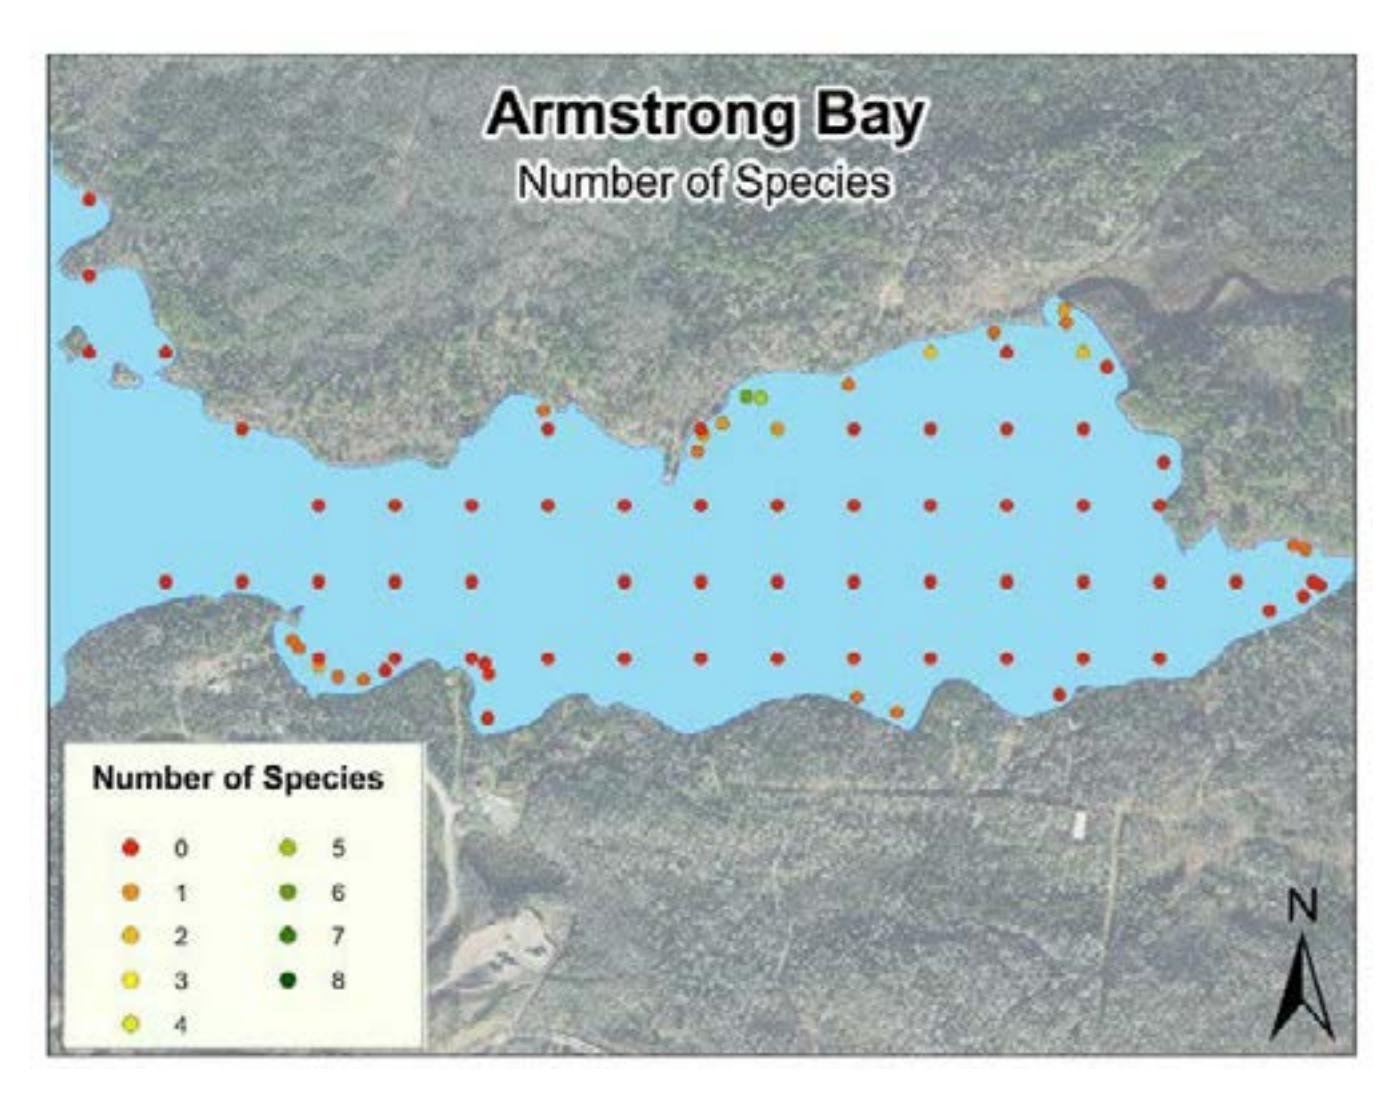
Figure 5. Armstrong Bay, Lake Vermilion Point-Intercept Survey with the number of species present per site, June 7, 2017.

The average number of plants per rake sample in Armstrong Bay was 0.4. Six was the maximum number of species sampled at one location in Armstrong Bay while one, two, and five species were sampled occasionally (Figure 5).

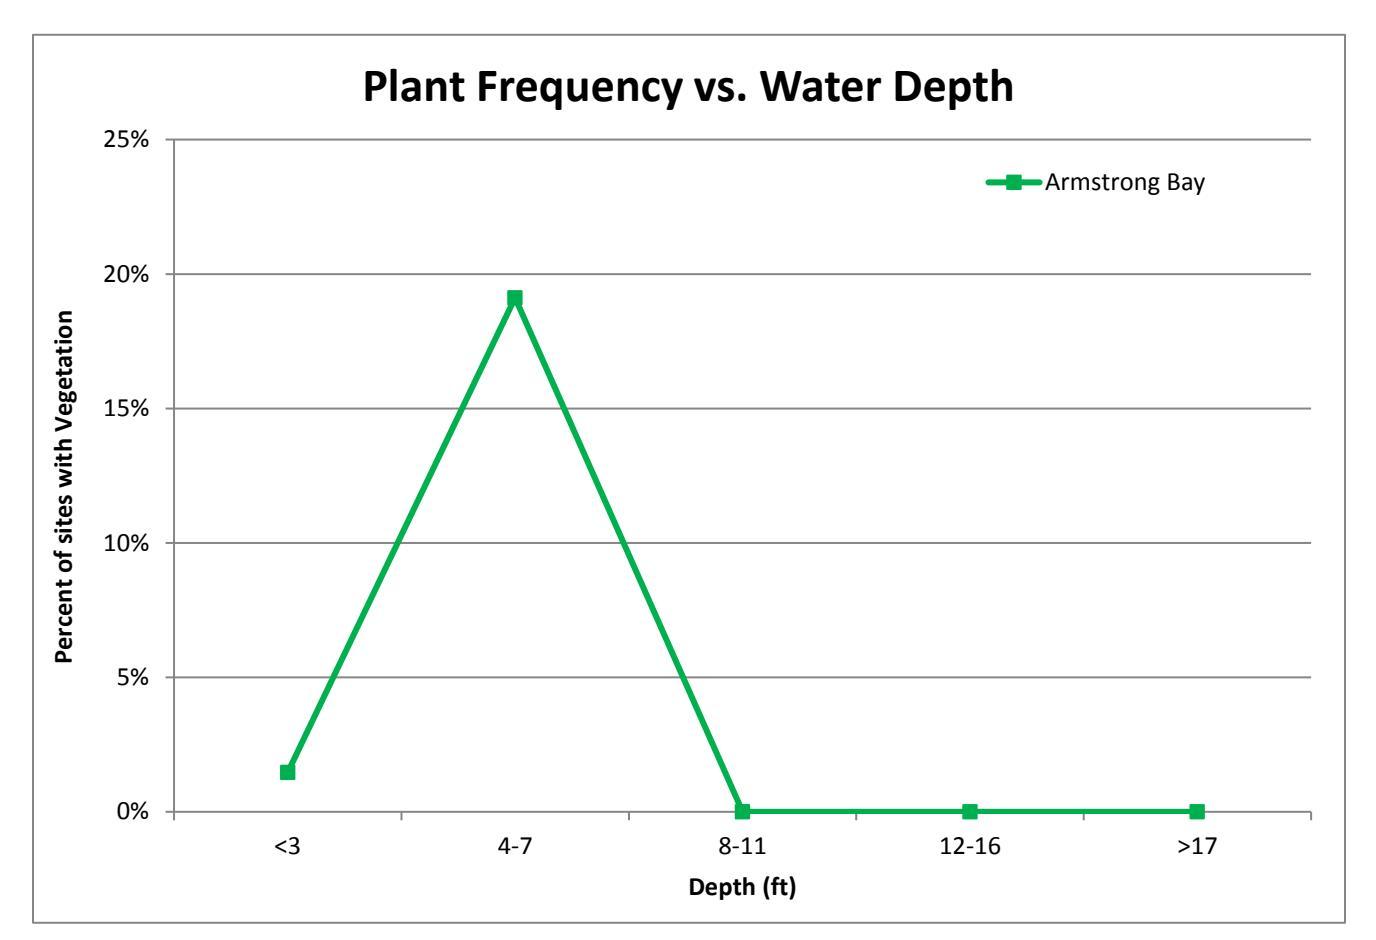
Sampling occurred to a maximum depth of 20 feet; however, no plants were found to be growing beyond 4 feet of water. Plant abundance was greatest between 4-7 feet of water. As depths increased beyond that range, the presences of vegetation decreased and became less dense (Figure 9).

Of the 83 sampled locations in Armstrong Bay, 64 sites had no vegetation present.

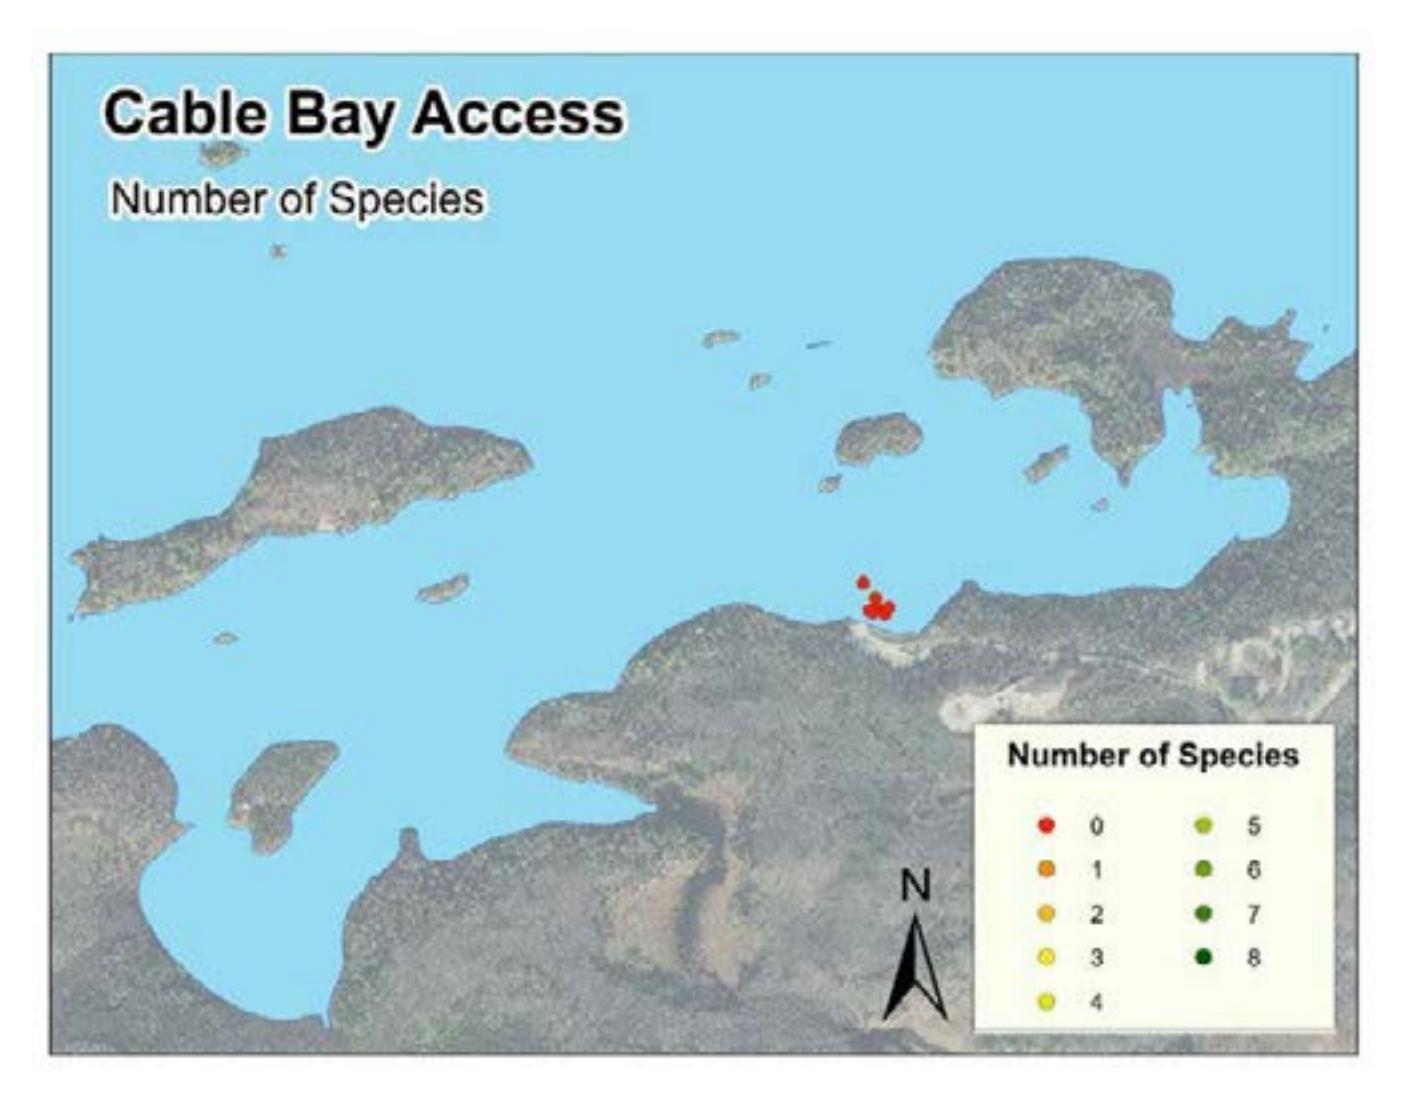
Figure 11. Cable Bay access, Lake Vermilion; number of species present per site, June 7, 2017.

No plants were found at the Cable bay access. The access was found to be very rocky and not suitable for plant growth.

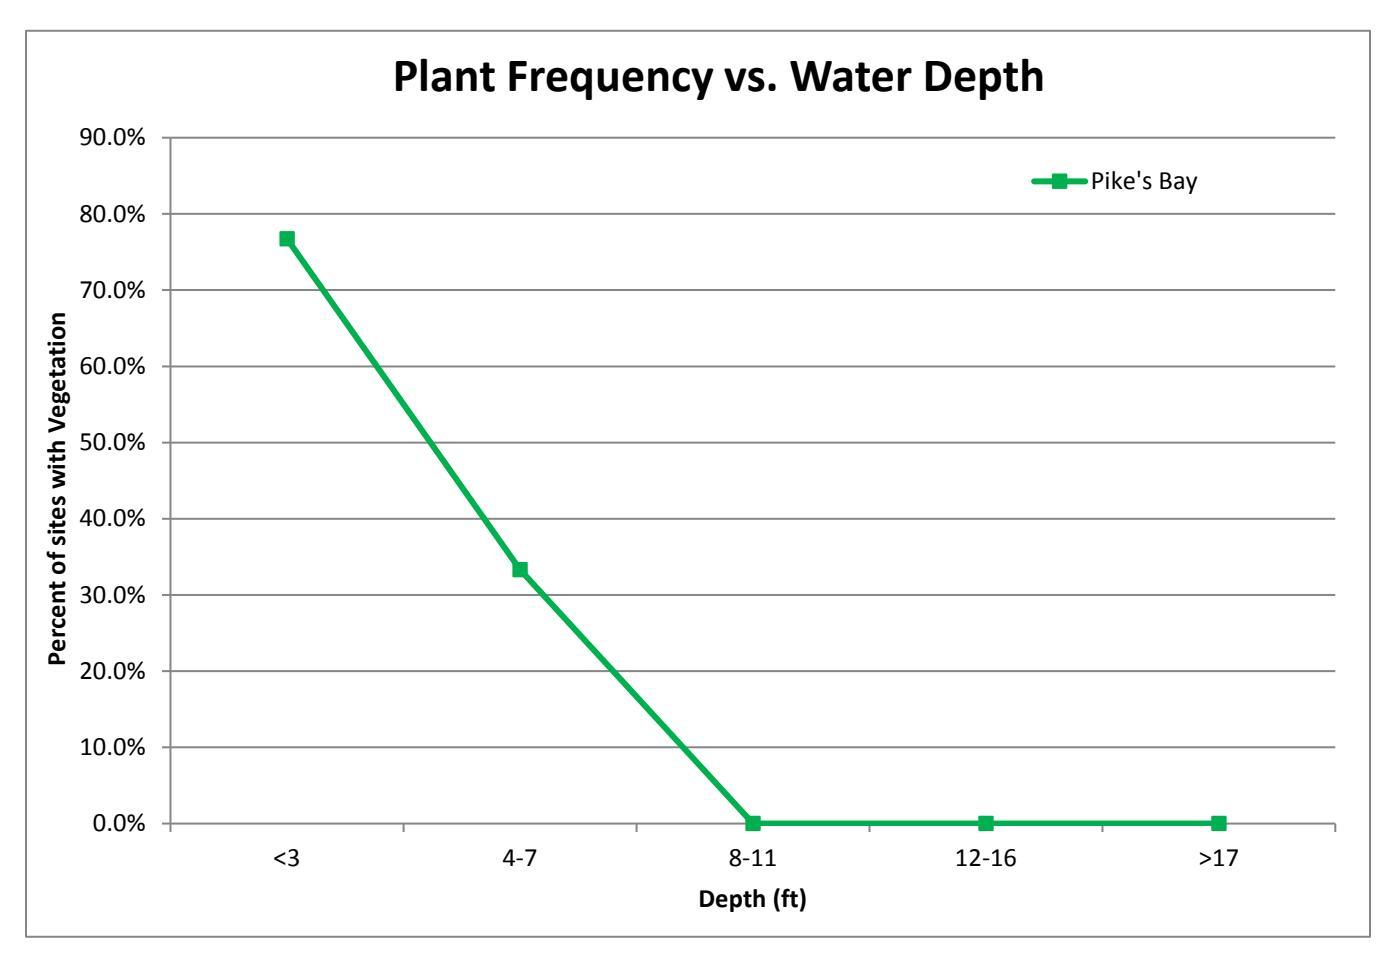
Sampling occurred to a maximum depth of 11 feet; however, no plants were found to be growing beyond 7 feet of water (Figure 16).

Figure 16. Frequency of vegetation vs. water depth, Pike's Bay, Lake Vermilion, St. Louis County, MN: June 7, 2017.

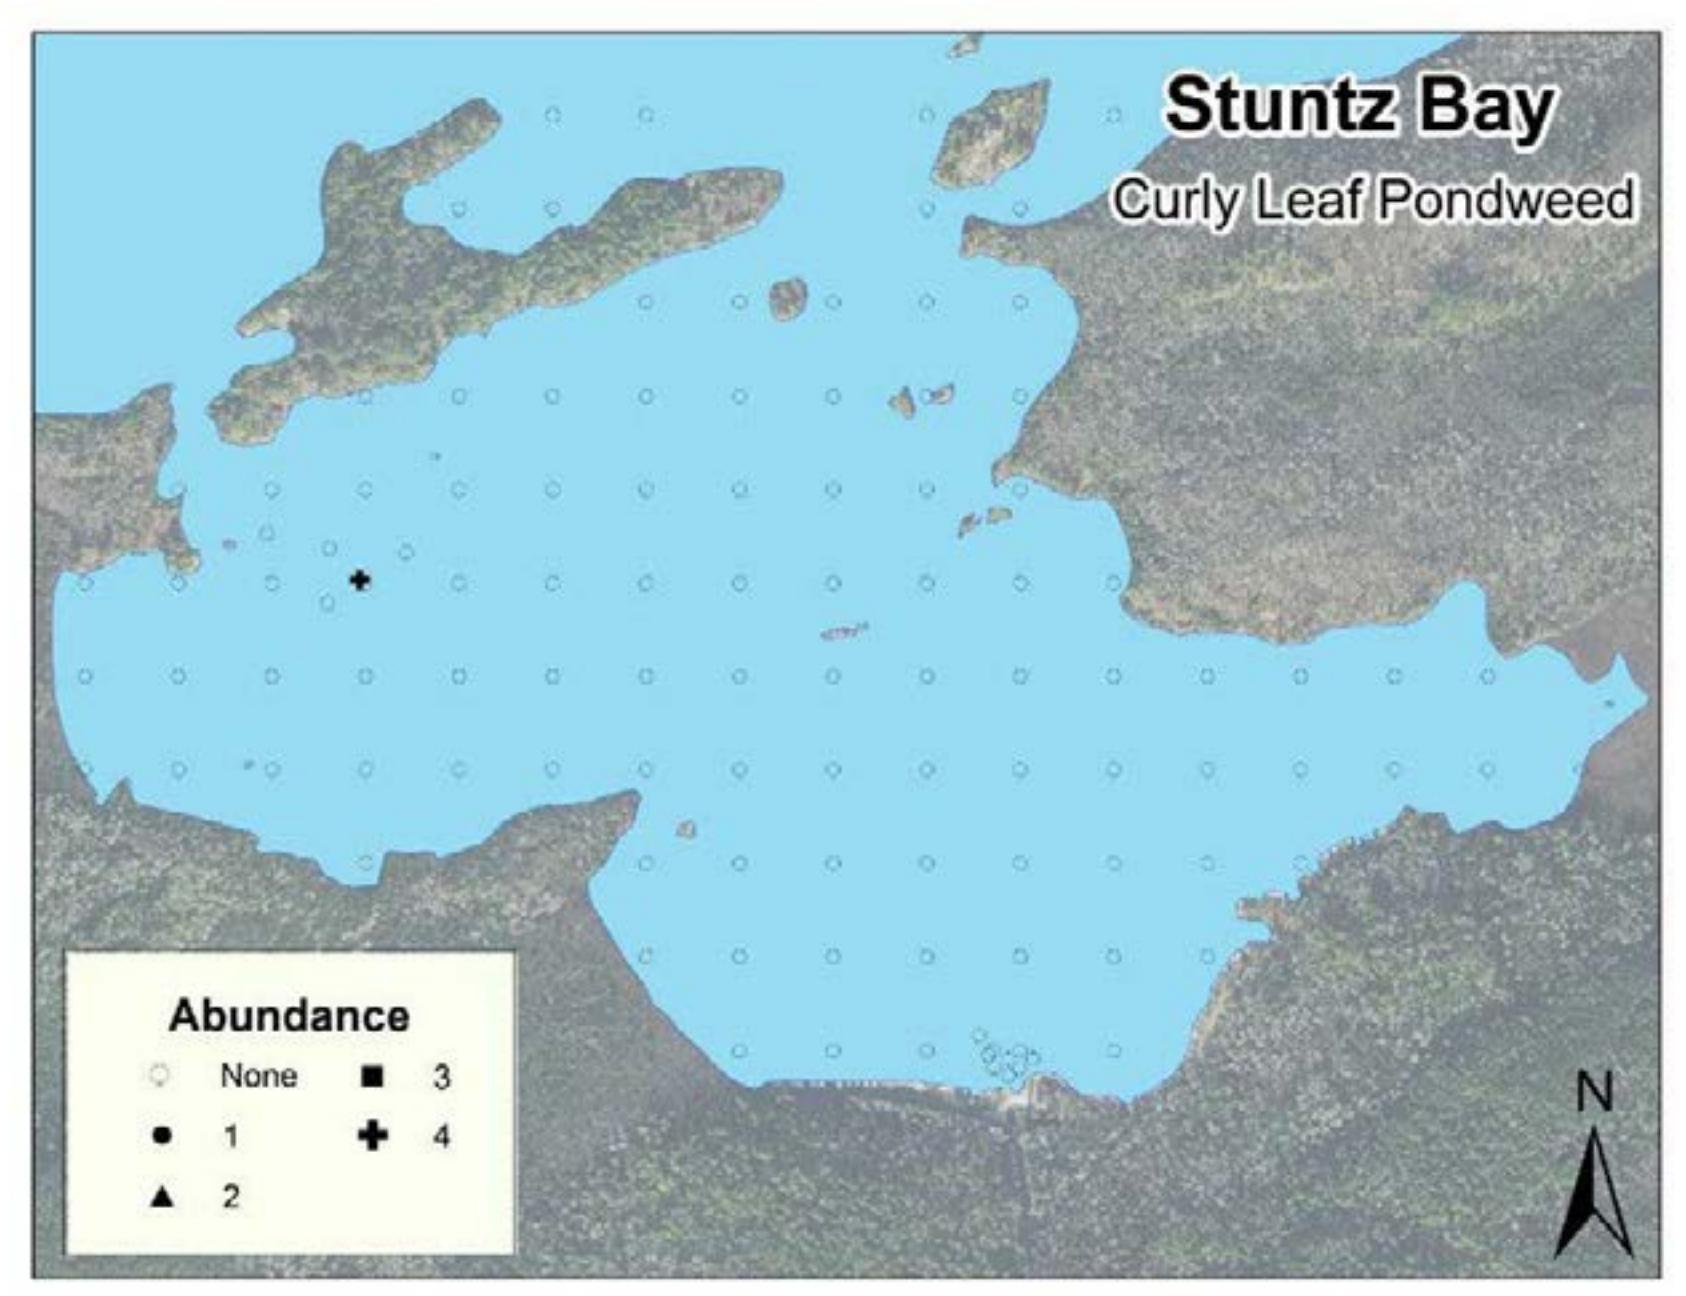
The invasive Curly-leaf Pondweed was found in the northwest portion of Stuntz Bay at low densities (Figure 19).

Figure 19. Curly-leaf areas in Stuntz Bay, Lake Vermilion Point-Intercept Survey, June 5 and 7, 2017.

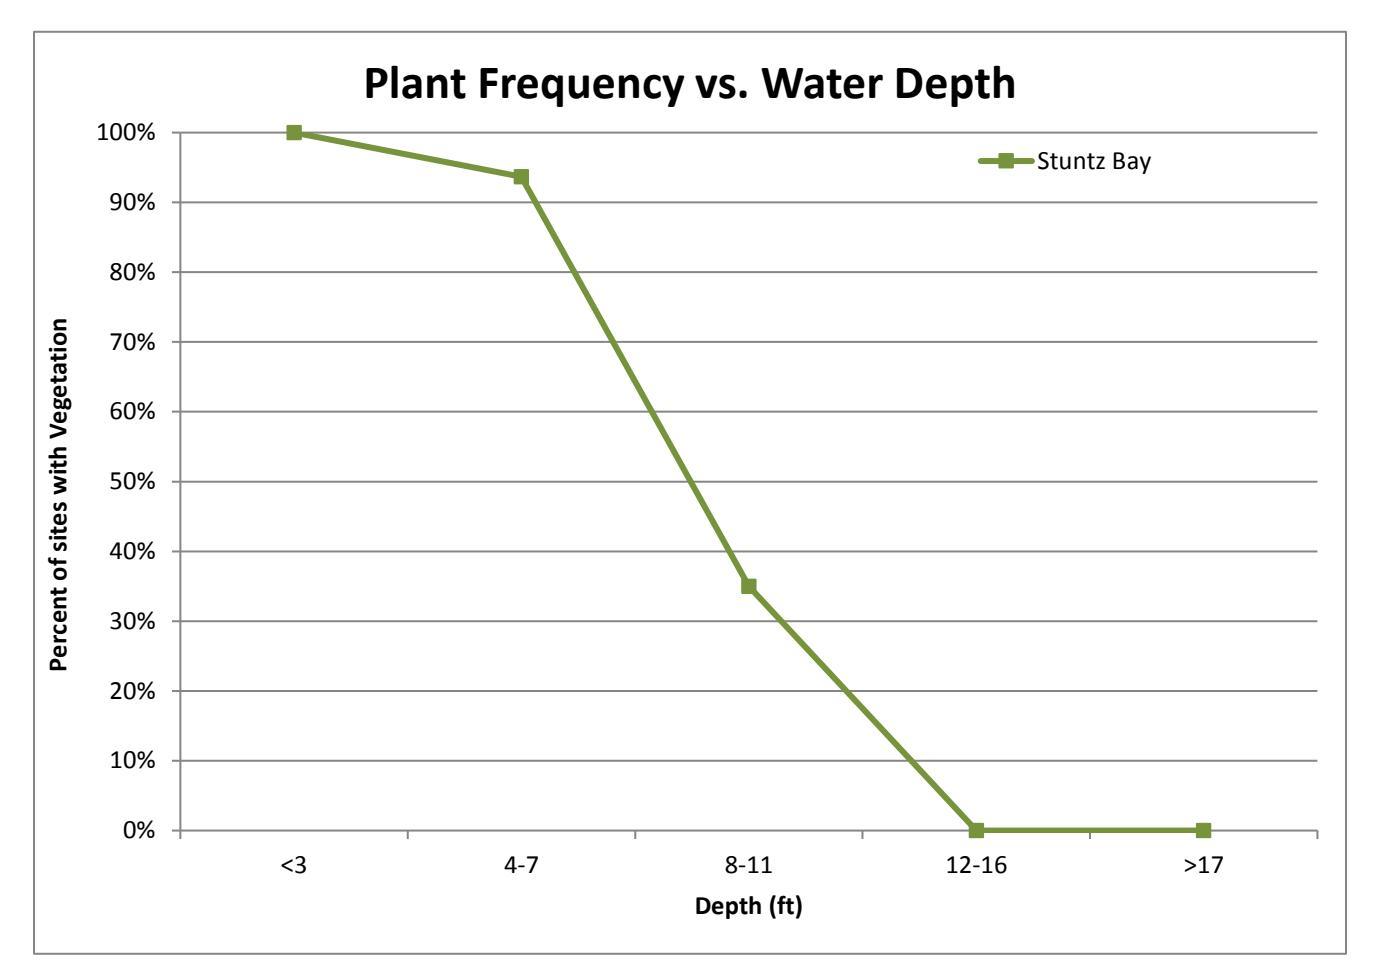
Sampling occurred to a maximum depth of 17 feet; however, no plants were found to be growing beyond 11 feet of water. Plant abundance was greatest between one and seven feet of water. As depths increased beyond that range, the presences of vegetation decreased and became less dense (Figure 23).

Of the 108 sampled locations in Stuntz Bay, 14 sites had no vegetation present.

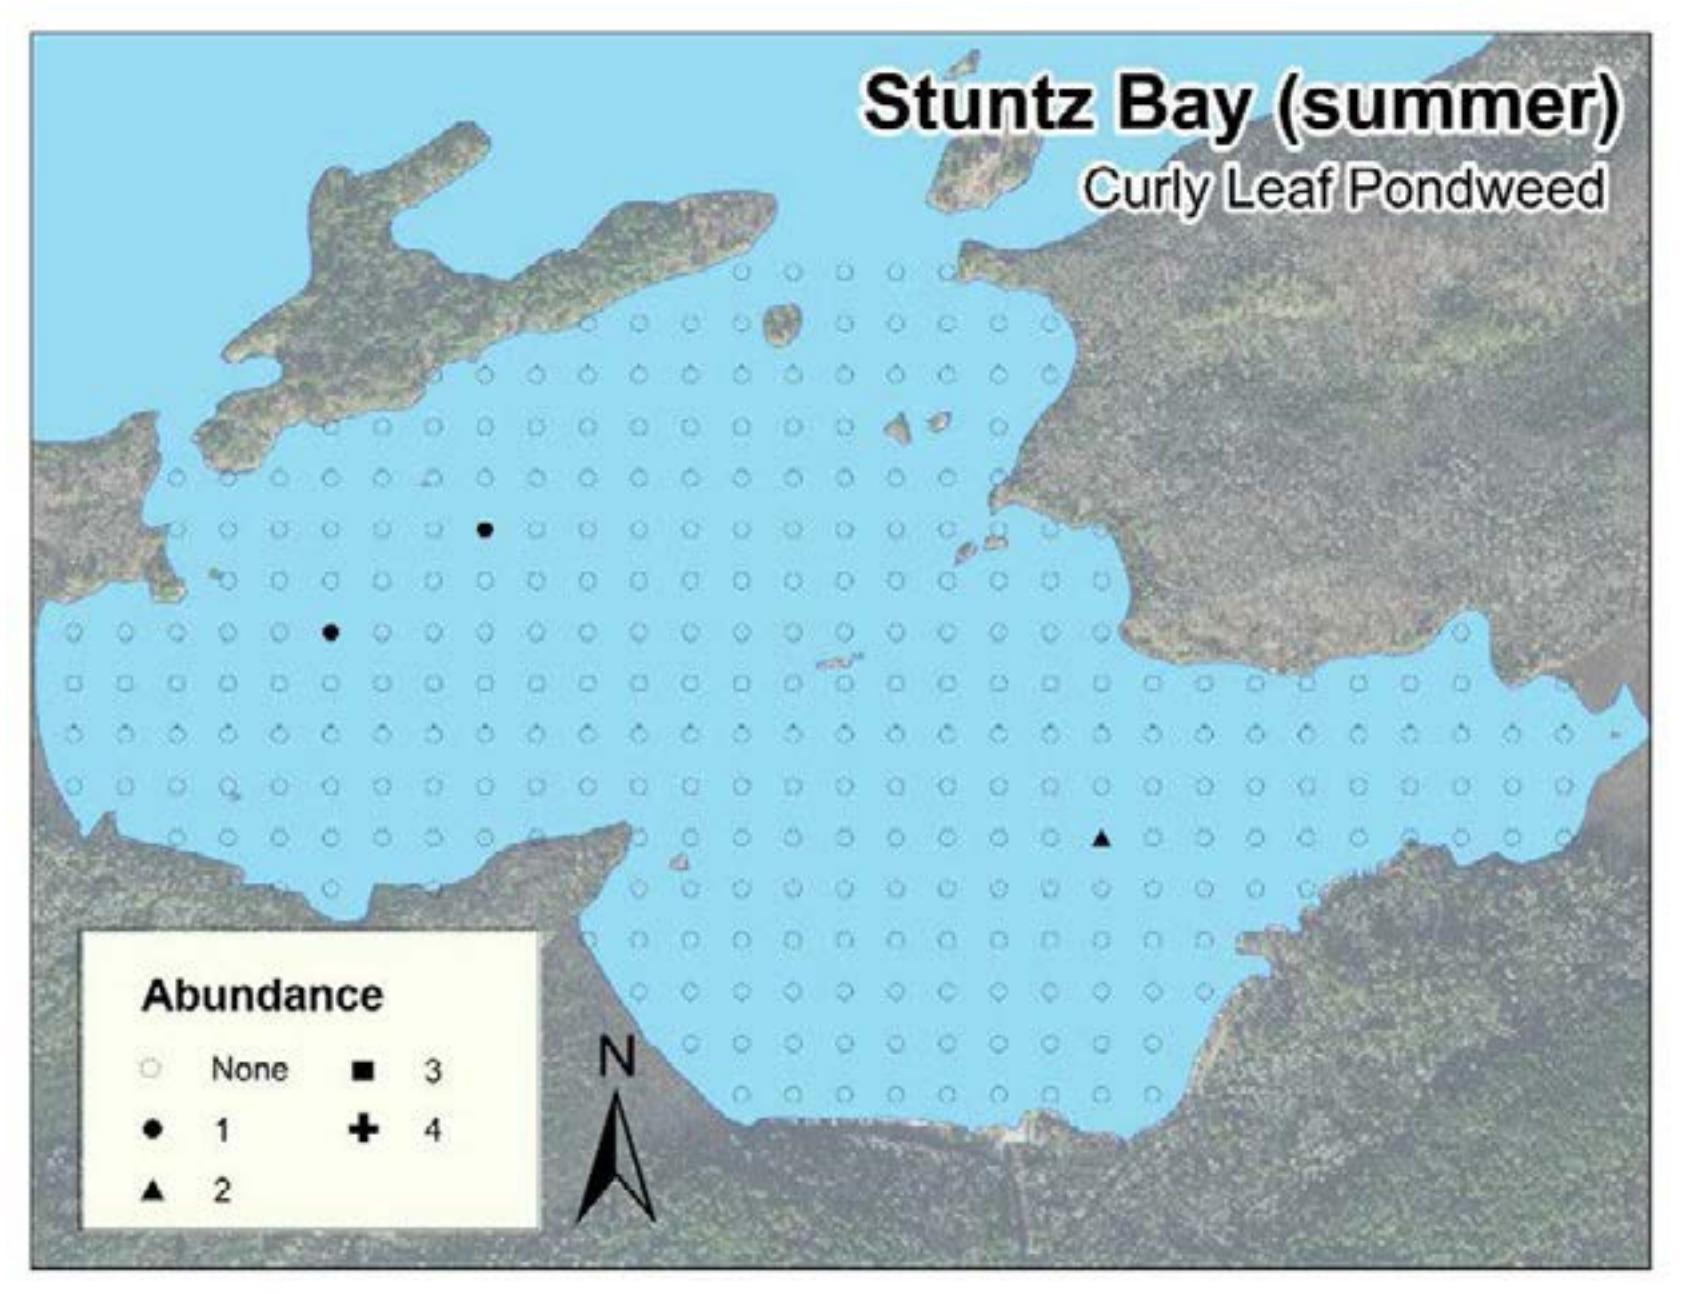
The invasive Curly-leaf Pondweed was found at two sites in the northwest and one point in the southeast portion of Stuntz Bay at low densities (Figure 26).

Figure 26. Curly-leaf areas in Stuntz Bay, Lake Vermilion Point-Intercept Survey, August 15, 2017.

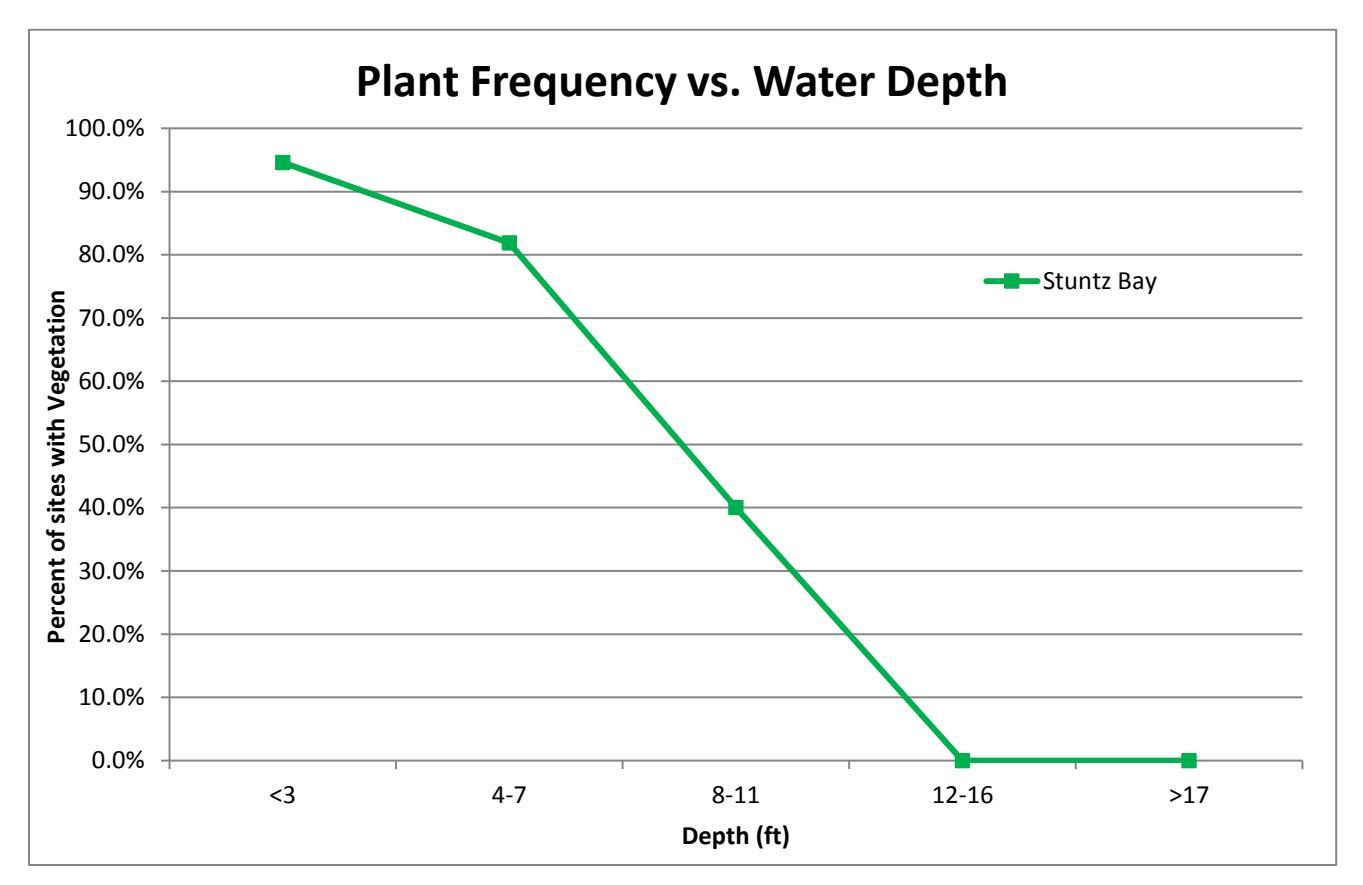
Table 5. Aquatic plants surveyed in Stuntz Bay, Lake Vermilion, St. Louis County, MN: August 15, 2017.
Sampling occurred to a maximum depth of 17 feet; however, no plants were found to be growing beyond 11 feet of water. Plant abundance was greatest below three feet of water. As depths increased beyond that range, the presences of vegetation decreased and became less dense (Figure 30).

Of the 292 sampled locations in Stuntz Bay, 70 sites had no vegetation present.

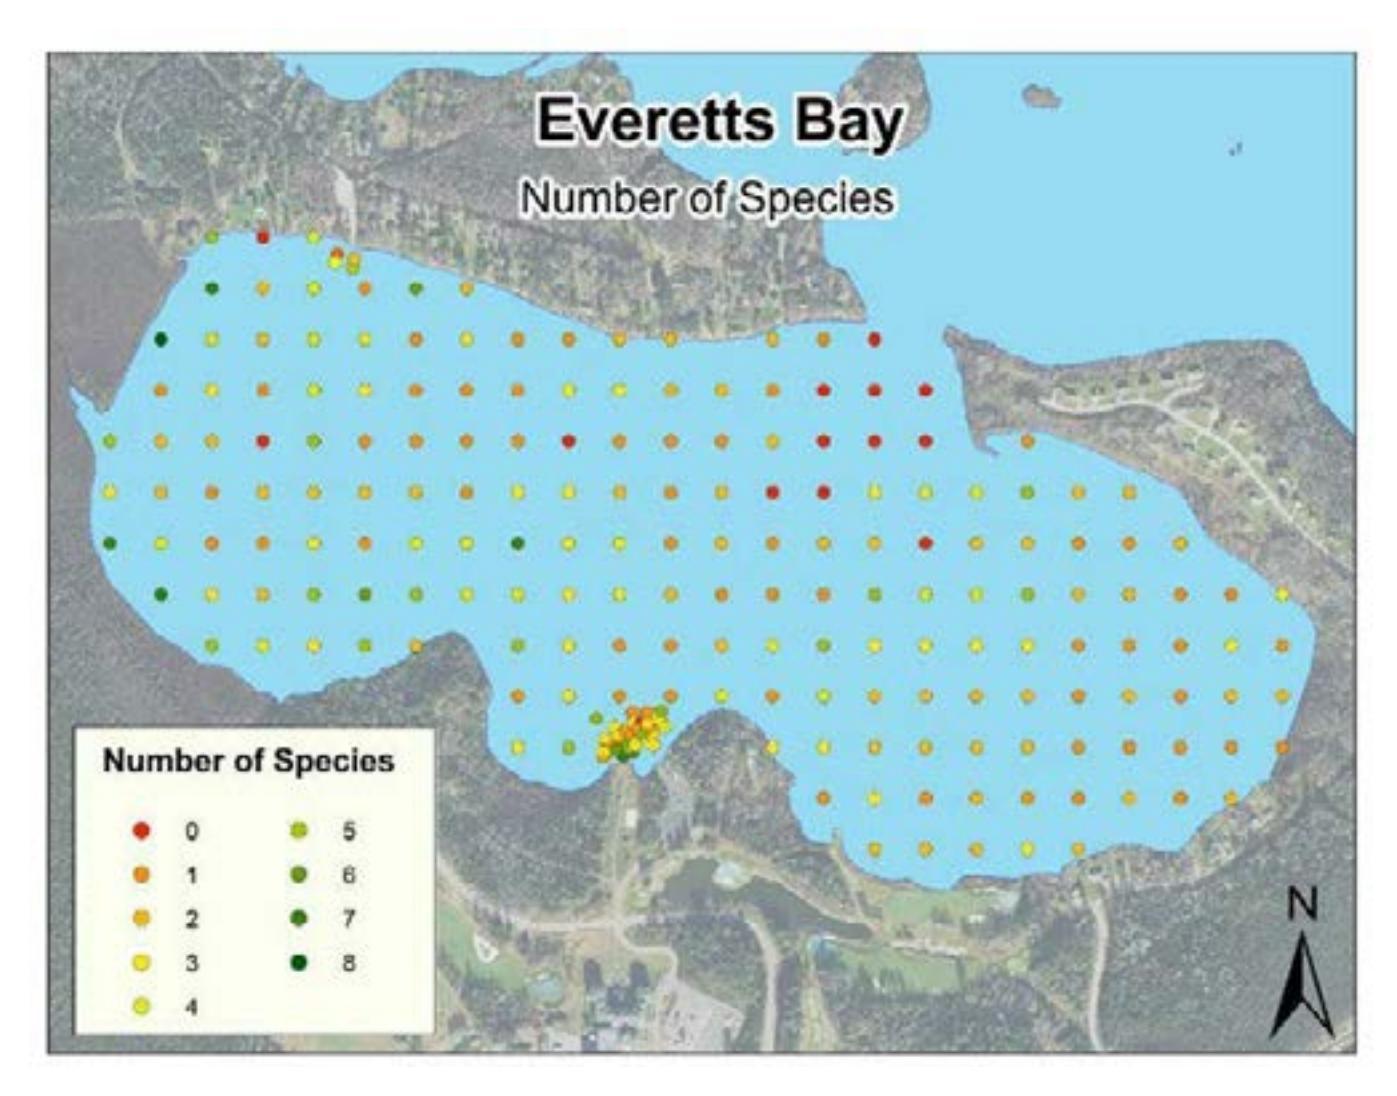
Figure 32. Everetts Bay, Lake Vermilion Point-Intercept Survey with the number of species present per site, June 6, 2017.

The average number of plants per rake sample in Everetts Bay was 2.3. Eight was the maximum number of species sampled at one location in Everetts Bay (Figure 32).

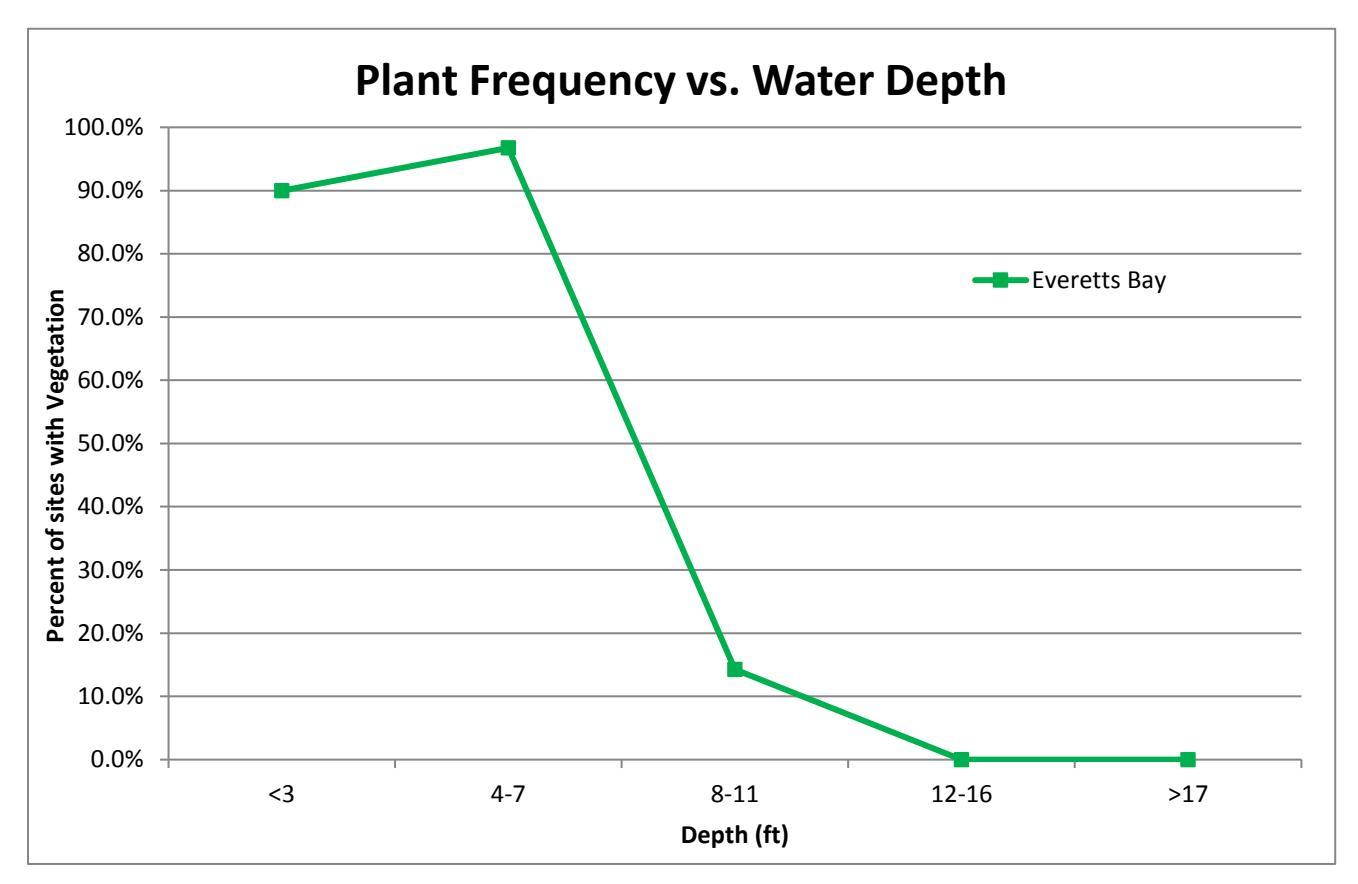
Sampling occurred to a maximum depth of 20 feet; however, no plants were found to be growing beyond 8 feet of water. Plant abundance was greatest between four and seven feet of water. As depths increased beyond that range, the presences of vegetation decreased and became less dense (Figure 37).

Of the 192 sampled locations in Everetts Bay, 15 sites had no vegetation present.

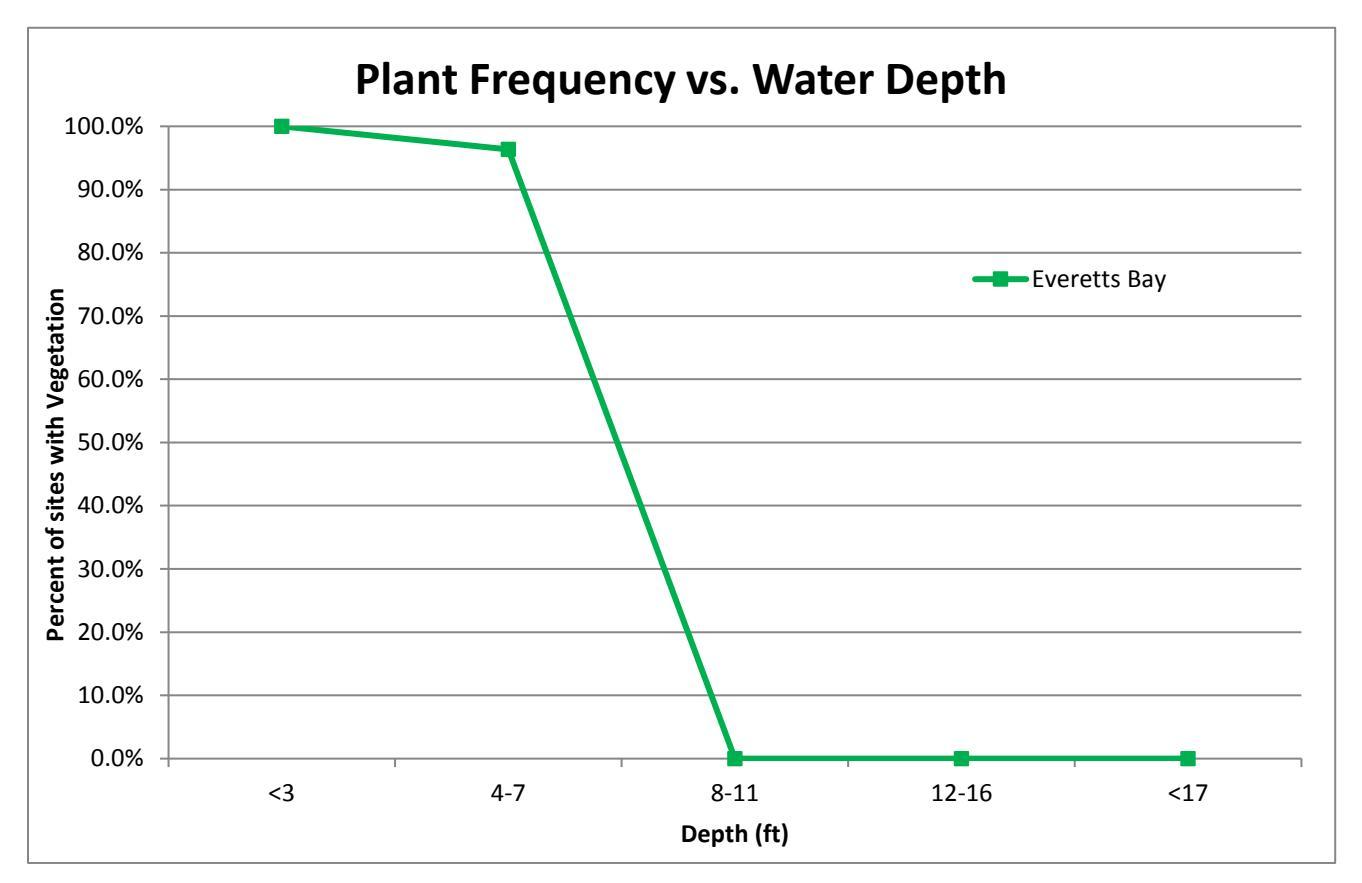
Sampling occurred to a maximum depth of 20 feet; however, no plants were found to be growing beyond 7 feet of water. Plant abundance was greatest up to three feet of water. As depths increased beyond that range, the presences of vegetation decreased and became less dense (Figure 44).

Of the 580 sampled locations in Everetts Bay, 15 sites had no vegetation present.

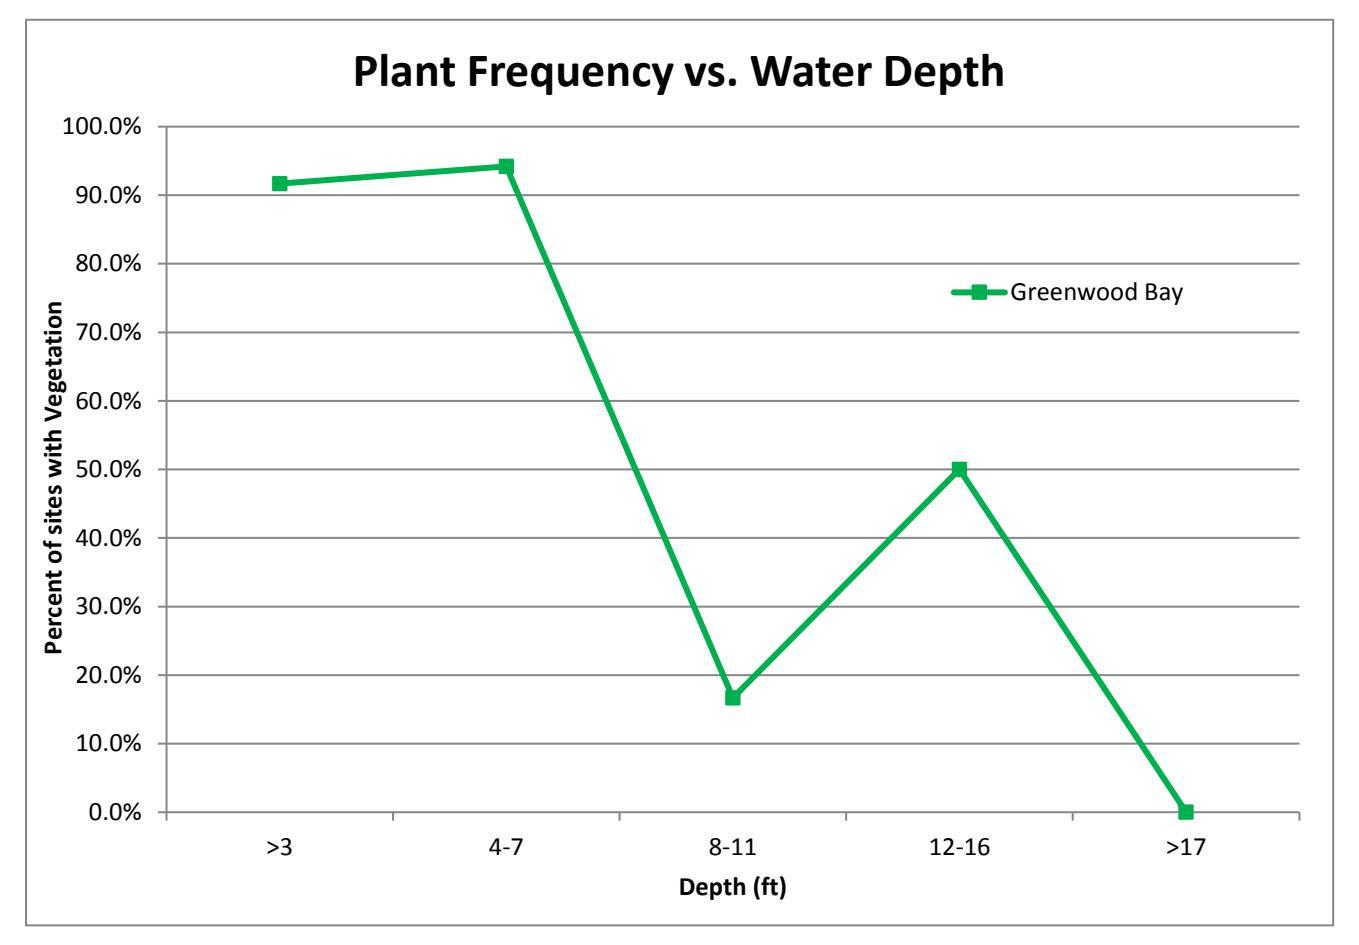
Sampling occurred to a maximum depth of 20 feet; however, no plants were found to be growing beyond 13 feet of water. Plant abundance was greatest between four and seven feet of water (Figure 50).

Of the 114 sampled locations in Greenwood Bay, 15 sites had no vegetation present.

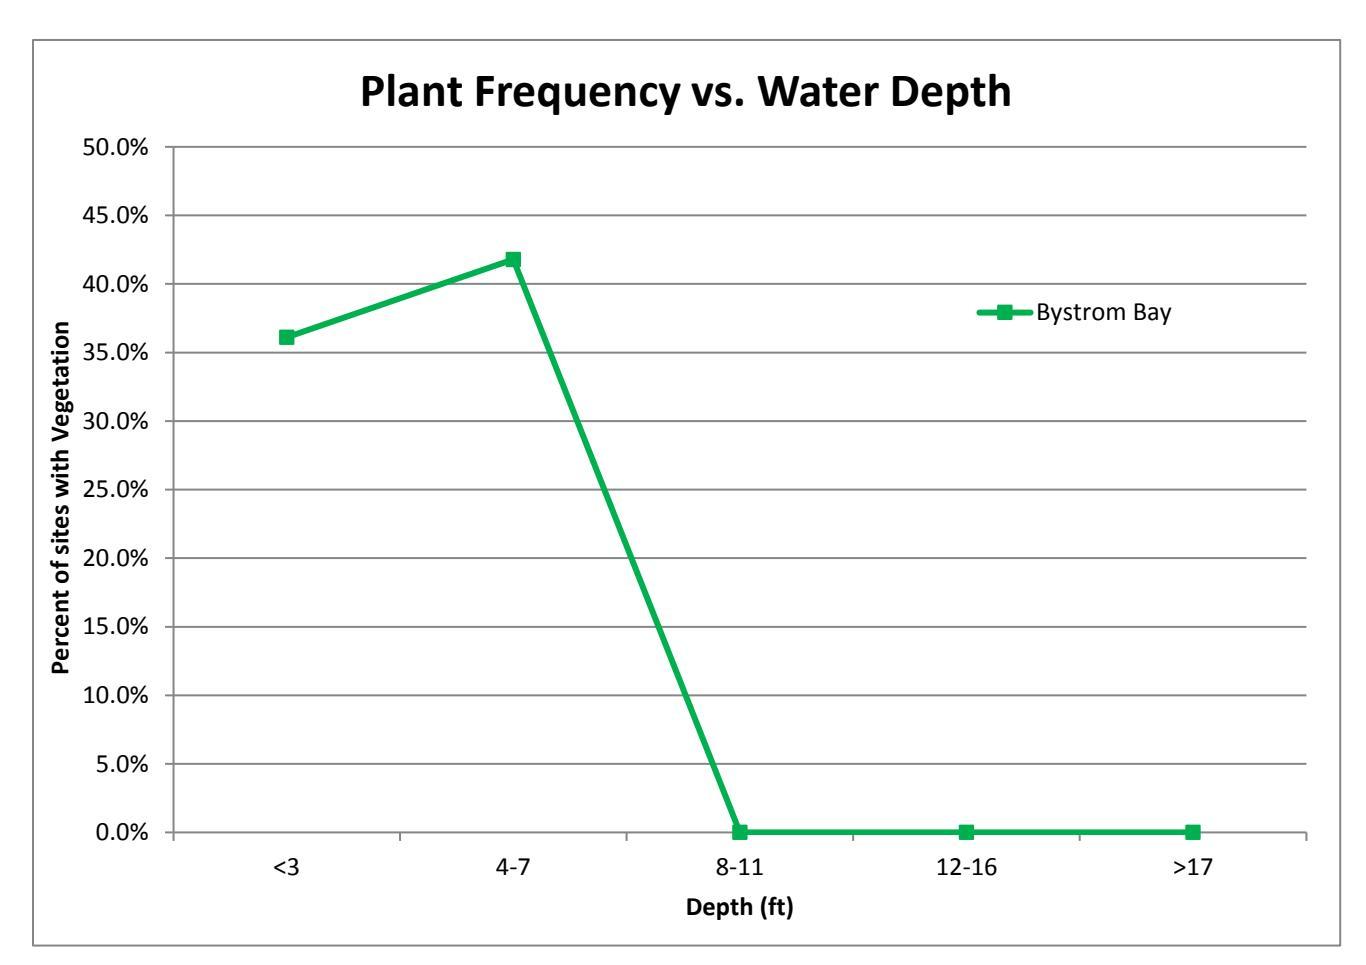
Sampling occurred to a maximum depth of 20 feet; however, no plants were found to be growing beyond 7 feet of water. Plant abundance was greatest between four and seven feet of water (Figure 56).

Of the 247 sampled locations in Bystrom Bay, 193 sites had no vegetation present.

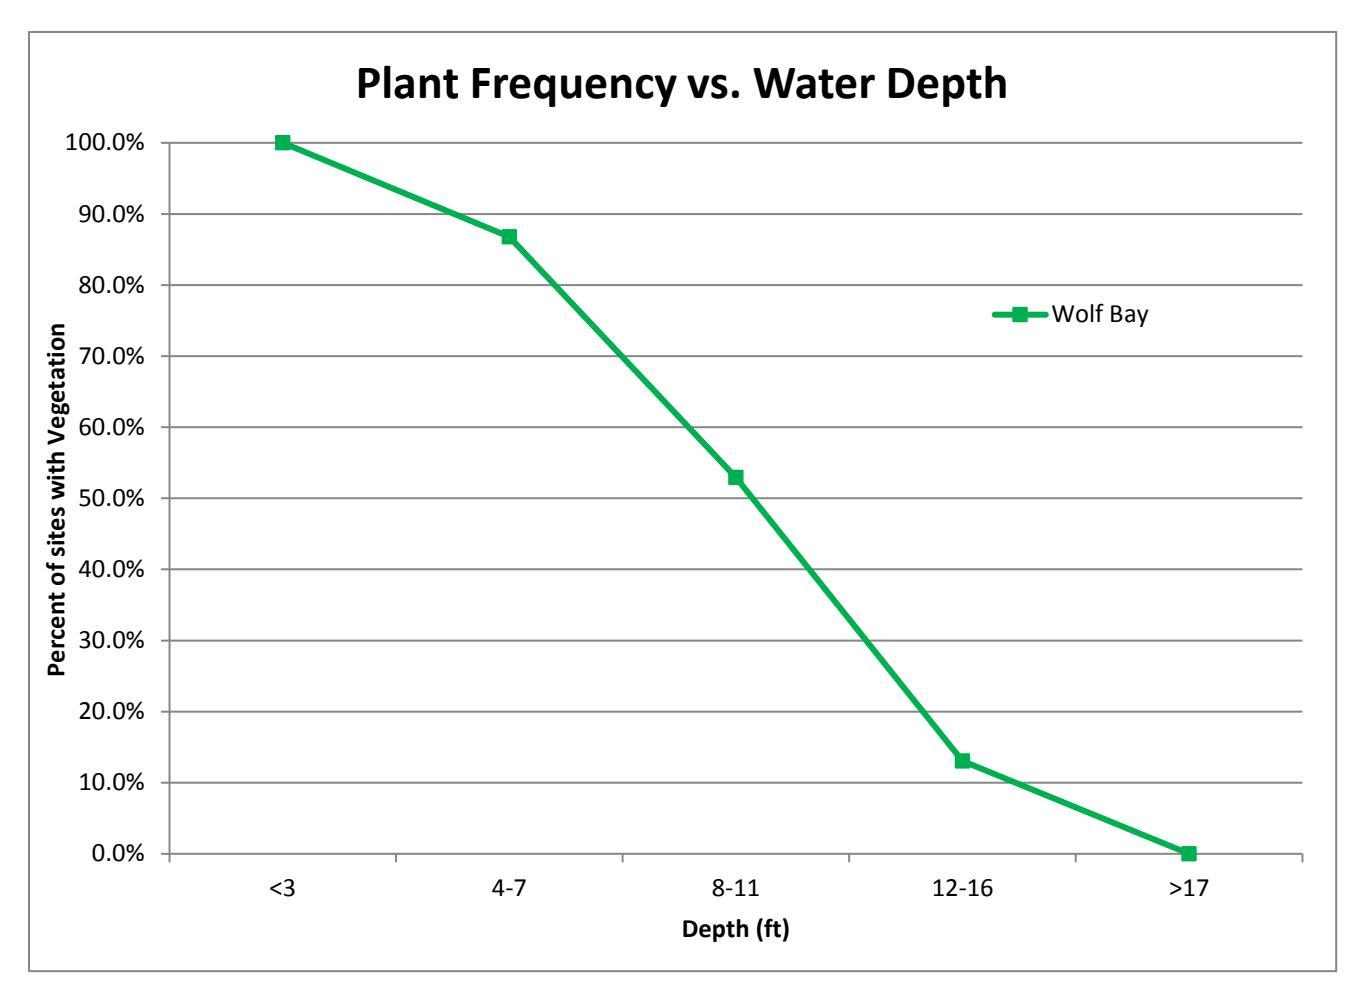
Sampling occurred to a maximum depth of 20 feet; however, no plants were found to be growing beyond 12 feet of water. Plant abundance was greatest below three feet of water (Figure 63).

Of the 180 sampled locations in Wolf Bay, 90 sites had no vegetation present.
