LAKE VERMILION (69 - 0378 - 00)

Aquatic Vegetation Survey

Lake: Lake Vermilion	DOW Number : 69-0378-00	Date of inspection: 6/ 5-9 & 11-15/17 and 8/14-18/17		
County: St. Louis	Observers: Emelia Hauck, Katherine Millette, Laura Geyen			
Author of report: Emelia Hauck		Date of report: October 5, 2017

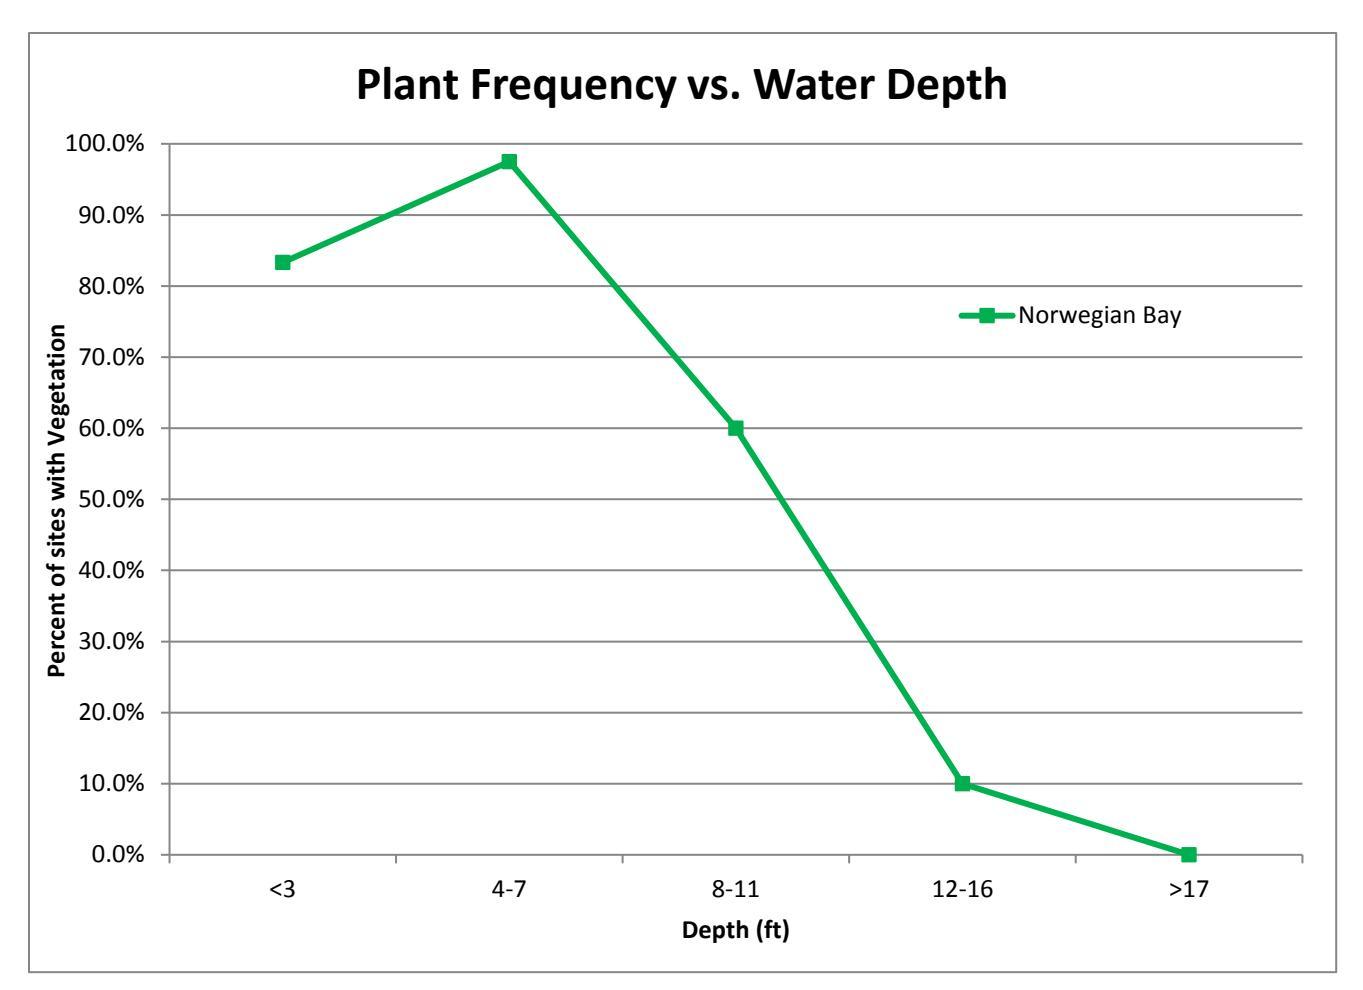
Sampling occurred to a maximum depth of 20 feet; however, no plants were found to be growing beyond 13 feet of water. Plant abundance was greatest between 4 and 7 feet of water (Figure 69).

Of the 157 sampled locations in Norwegian Bay, 89 sites had no vegetation present.

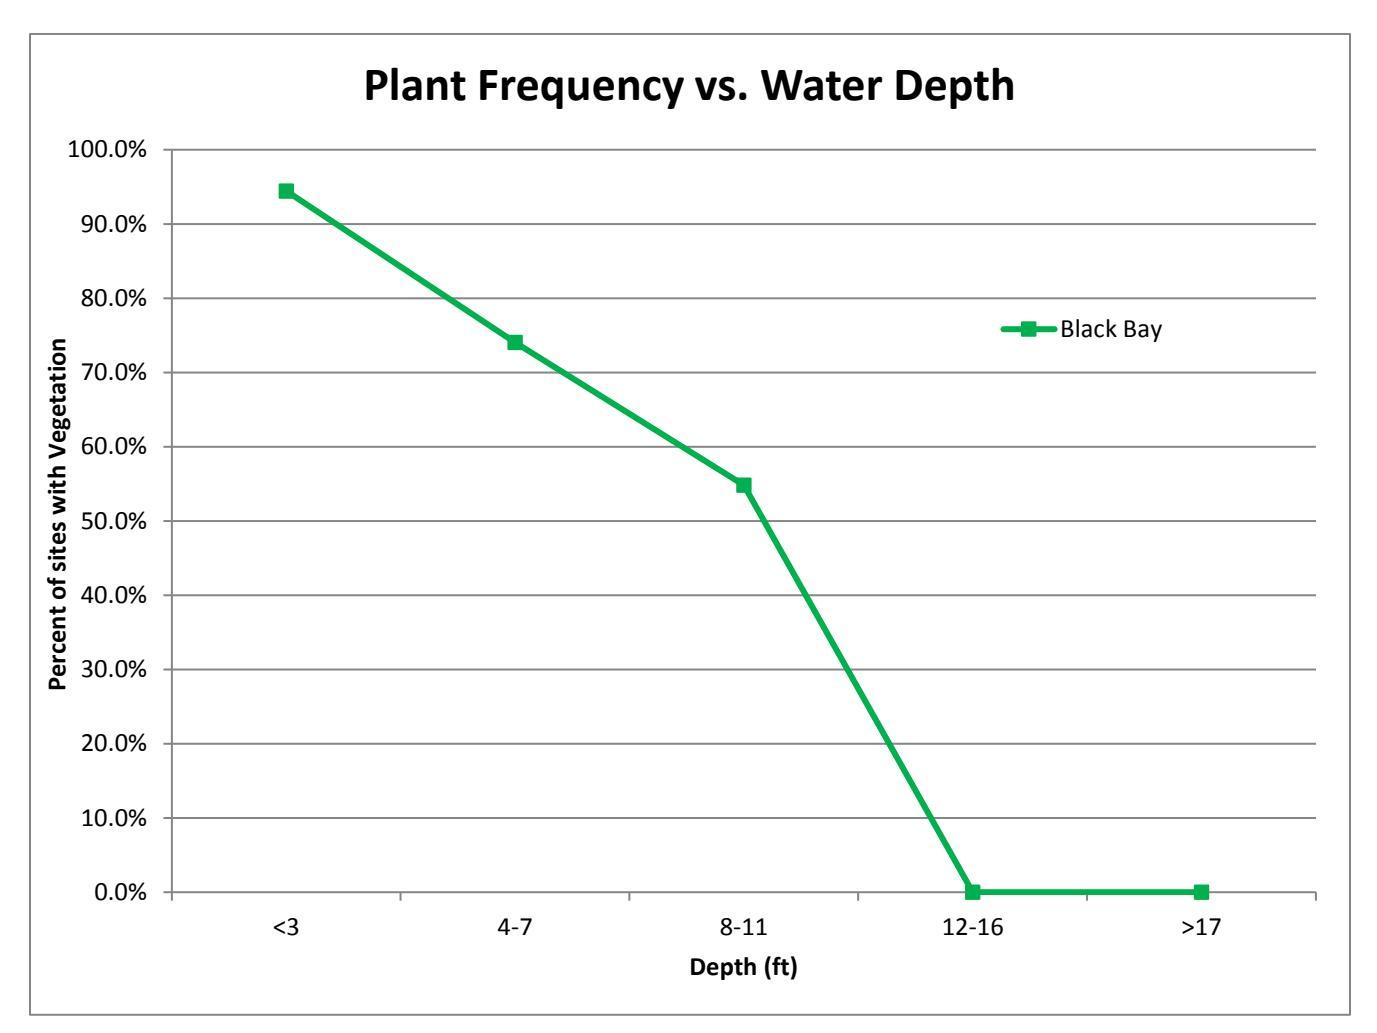
Sampling occurred to a maximum depth of 20 feet; however, no plants were found to be growing beyond 12 feet of water. Plant abundance was greatest up to three feet of water (Figure 75).

Of the 173 sampled locations in Black Bay, 65 sites had no vegetation present.

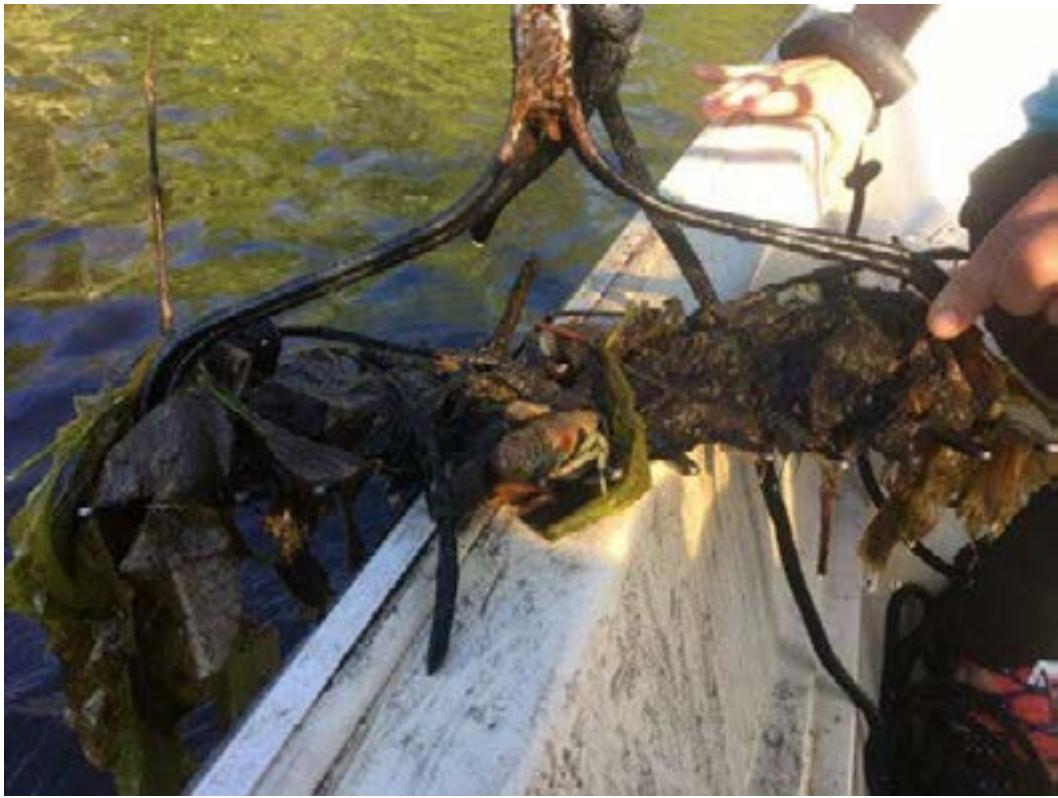
Figure 99. Rake with Rusty Crayfish, Lake Vermilion on June 7, 2017.

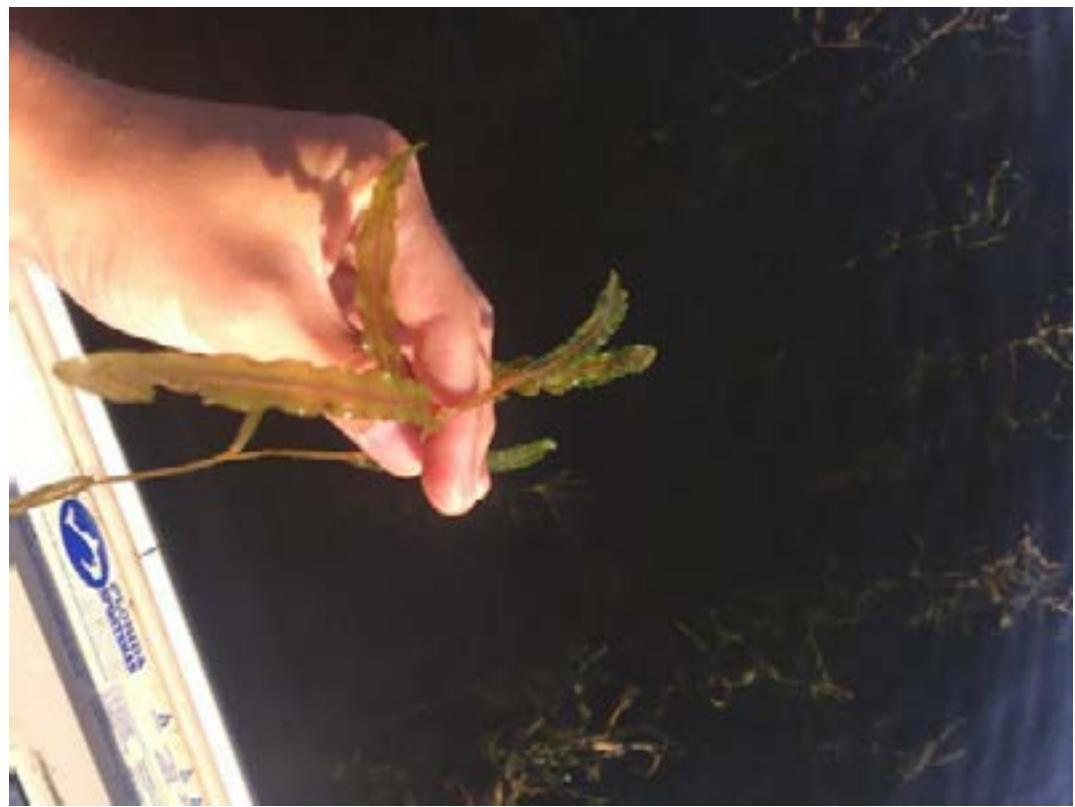
Figure 100. Curly Leaf Pondweed in Wolf Bay, Lake Vermilion on June 9, 2017.
